CITY OF KELOWNA

MEMORANDUM

Date: April 15, 2008
File No.: 0710-20
To: City Manager
From: Civic Properties Project Supervisor
Subject: Laurel Packinghouse Structural

Structural Review
of the
Laurel Packinghouse Building
(The Wine Museum)
130-4 Ellis Street, Kelowna

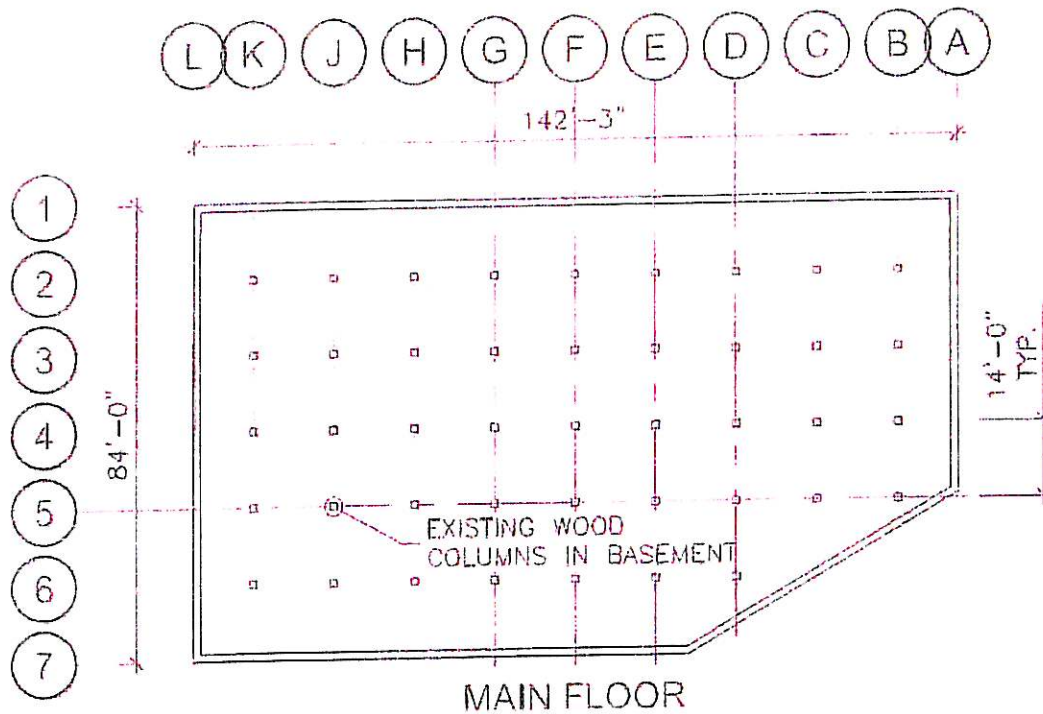
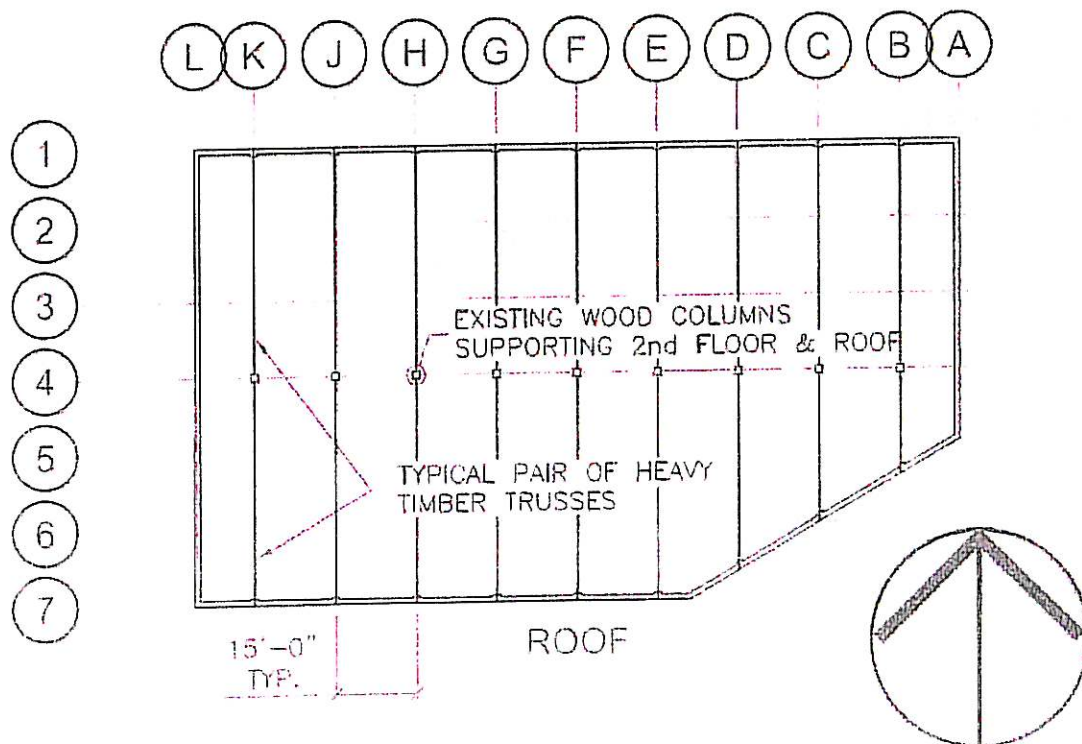
Figure 1

Load Path Analysis

Implementation of the 1983 Woodworth design involved removal of a substantial portion of the original roof surface and replacement of that surface by a new continuous shed dormer on either side of the ridge. This work effectively eliminated the diaphragm function of the original roof surface over the extent where that original roof was removed. Outside the bounds of the new shed roof, two rows of skylights were added, one in each bay between adjacent trusses. These skylights limit the effectiveness of the remaining portion of the original diaphragm. Furthermore, the new shed roof surfaces cannot be said to act as an effective roof diaphragm, because they do not connect with any wall element that might act as a shearwall. That is, the 'outside' wall at the extremity of each shed roof is perforated by a continuous strip of fenestration, and no wall exists beneath the intersection of the 1983 shed roof surface and the original roof surface.

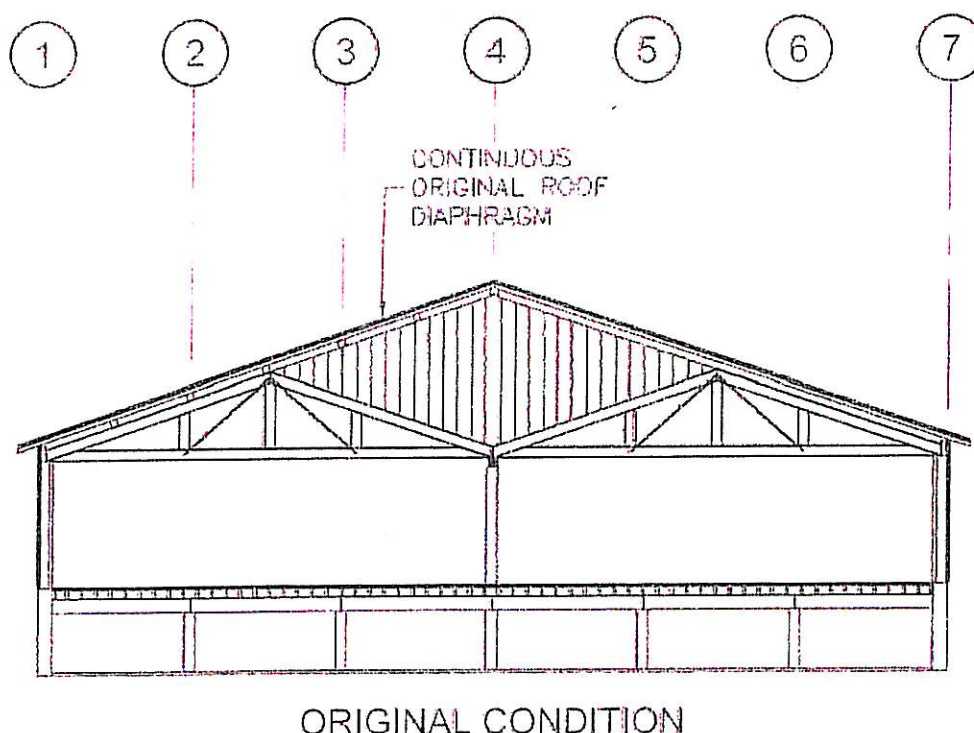
Figure 2

The second floor added in 1983 cannot be said to act as a diaphragm because it does not meet or connect with any wall element below. Also, given that the second floor is discontinuous across the width of the building (i.e.: the centre corridor is higher than the floor on either side), diaphragm action is further compromised.

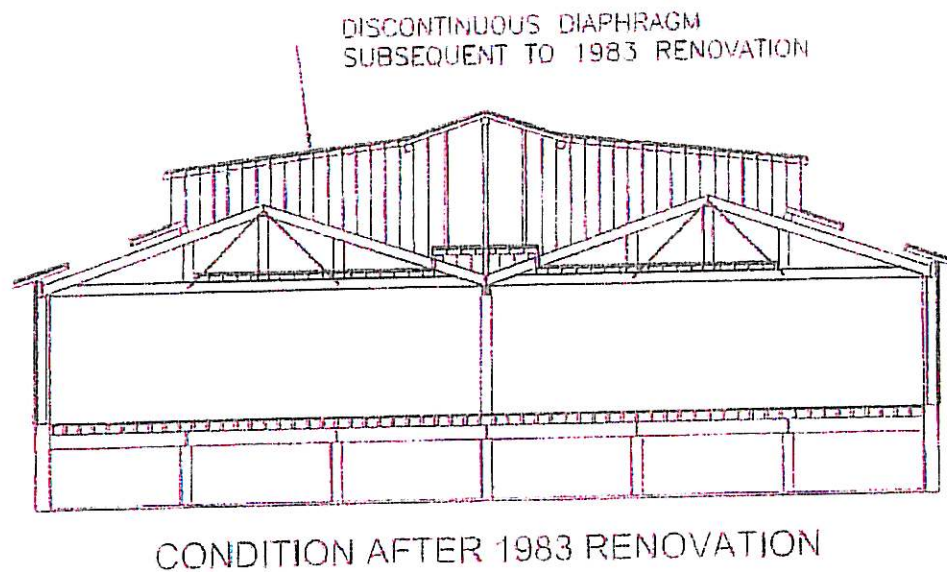
Figure 3

The upshot of this discussion is that there presently exists no well-defined path by which lateral loads in either orthogonal direction might be transmitted into the foundation. The discontinuous nature of the load path for lateral loads might best be illustrated by reference to Figures 4, 5 and 6, being three-dimensional renderings of the building in the 'before' state (Figure 4), 'after' the 1983 renovation (Figure 5), and after the 1983 renovation, with the roof removed to provide a clear view of how the second floor diaphragms are not connected to the perimeter shearwalls. It must be noted that the existing heavy-timber trusses do nothing as regards resistance to lateral loads; for lateral loads in the north-south direction, these trusses merely transfer lateral loads from the second floor diaphragm into the heavily-perforated roof diaphragm. Similarly, the shed roofs over the new (1983) second floor offices cannot be counted on to contribute anything to the stiffness of the roof diaphragm because of the continuous strip of windows. The glazing would have to act as part of the diaphragm for the shed roofs to be effective, and this is clearly not allowed.

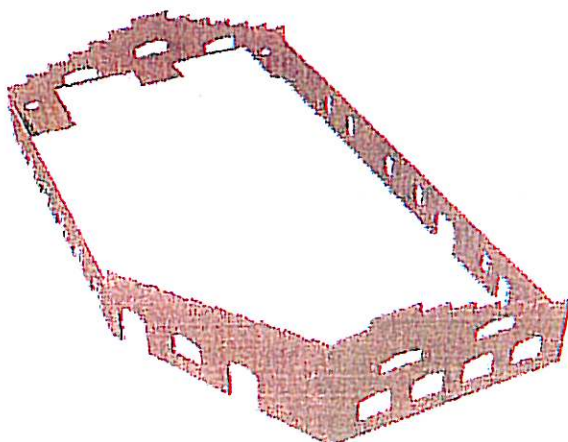
Figure 6 -- Unconnected 2nd floor diaphragm

Considering lateral loads in the east-west direction, we recommend the addition of such blocking, strapping and hold-downs as are required to ensure that the roof and second floor diaphragms act as a unit. Once this is accomplished, it is necessary only to transfer lateral loads from the underside of the second floor to the north and south side masonry walls. This may be accomplished by the addition of steel rod bracing at each of six locations, installed at the elevation of the truss bottom chords, as shown on the bottom half of Figure 8. The two north-south oriented shaded areas (i.e.: one between grid lines "E" & "F" and one between "I" & "K") are intended to denote two discrete diaphragms, each of which includes three X-braced bays and two areas of existing wood-frame floor. The existing trusses function as continuous chords for each of these diaphragms.

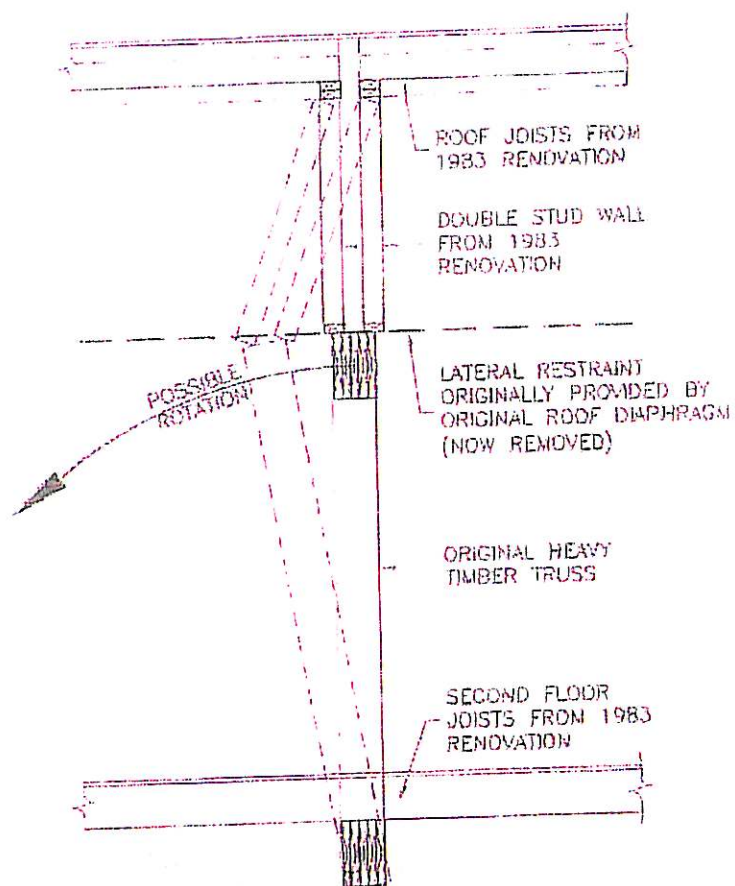
Figure 7

Almost as a by-product of the above discussion, it must be noted that the 1983 renovation removed the means by which lateral support was provided for the top (compression) chord of the original heavy timber trusses. This is a serious omission, since the original roof surface (now removed) was the only structural element employed to prevent buckling of the top chord.

Figure 7, taken from Section 2 on drawing A7 of the 1983 Woodworth drawings, illustrates the failure mechanism associated with buckling of the top chord of a typical heavy timber truss. While such a failure may seem unlikely in light of the passage of more than twenty years since the 1983 renovation, there presently exists nothing to prevent it. The existing detail might actually allow top-chord buckling of one truss while adjacent trusses remain unaffected (i.e.: adjacent trusses contribute no lateral restraint). Thus, local buckling failure of an individual truss might conceivably occur under the influence of a heavy snow load on the roof, even if the overall snow load on the roof were small. While such a contingency might appear remote, the means to prevent it does not exist at present.

In addition to these lateral-load-resisting systems, and with reference to Figure 7, we recommend that a steel brace be added to each side of the peak of each heavy timber truss, continuous between and attached to each of the bottom chord of the truss and the new (1983) high roof.

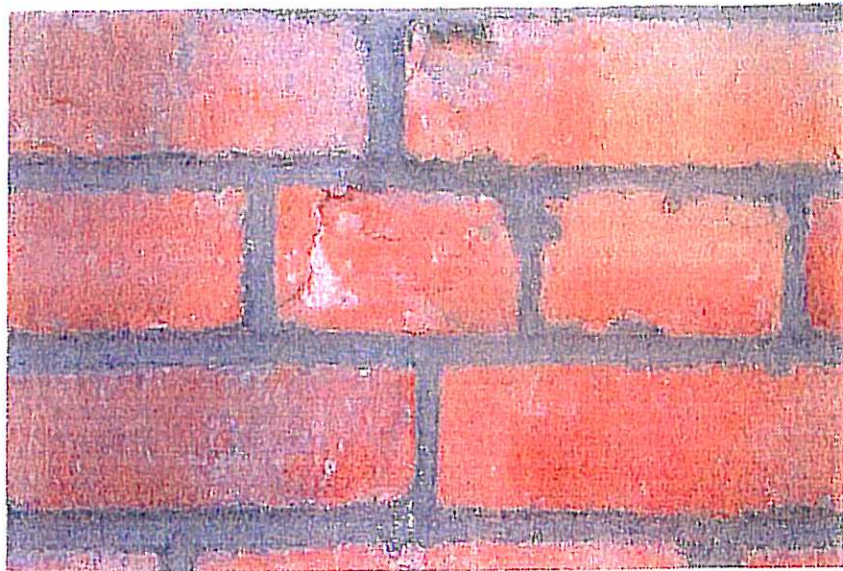
The brick walls are pointed with a grey mortar finished in a flush joint. The mortar dates from the 1983 rehabilitation. Its grey colour is indicative of a high cement content present in the mix. This creates a hard chemical set which is brittle and dense.

The mortar is in very good condition with the only sign of decay being in the areas of structural cracking, as mentioned above. However, its hardness may ultimately cause problems with the building. Mortar should be sacrificial i.e. it should decay before the masonry. In this case, the mortar is harder than the masonry so if one element were to decay first it would be the brickwork. Also, if the mortar were softer than the brickwork cracks would generally appear in mortar before bricks, which is easier to repair.

Fig 18: Detail of cementitious mortar with spalled brick. North elevation

- Monitor cracks in brick and concrete and continue to investigate
- Removing the cementitious mortar at this stage would be more damaging to the brick. However, if decay (efflorescence, spalling) continues or carrying out repairs, use weaker, lime-based mortar.
- Restore window and door styles, based on archival images. Preserve existing original windows.
- Remove existing attachments on north and south elevation. Keep south-east ramp and promenade (if code compliant). Reinstall original loading docks, with necessary modification to comply with code. These modifications should be contemporary, simple and visually unobtrusive.
- Restore original roof profile by removing shed dormers. Later skylights can be retained for internal illumination.
- Introduce an historically-appropriate roof ridge sign similar to the one on this nearby building in the 1928 photograph.

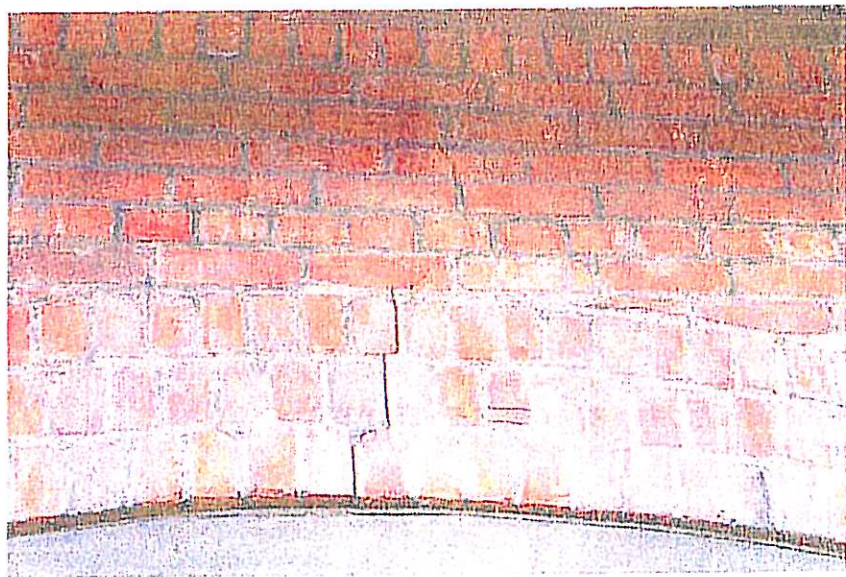
Although the bricks are soft, they are generally in good condition. They appear to be relatively free of impurities such as iron, which can accelerate the deterioration. However, there were two types of decay recorded on the building. Cracks, approximately 1/8" wide have formed centrally over some arches on the north and south elevations. The cracks run through the brick and mortar. These should be further investigated because their locations may be related to the roof structure. Efflorescence, a powdery deposit of salts, was visible in one area of the north façade. This is caused by salts from within the brick/mortar dissolving in the presence of water and as the brick dries out, the salts deposit on the brickwork. It can be unsightly, but not necessarily damaging. However, in this instance the build-up of salts under the surface of the brick has caused some of the brick face to fall off (spall) due to the pressure from the salt crystals. This is an isolated incident but an indication that the mortar is not assisting moisture to evaporate, as it should.

Fig 19: Example of typical cracking through brick and mortar over window opening. South elevation

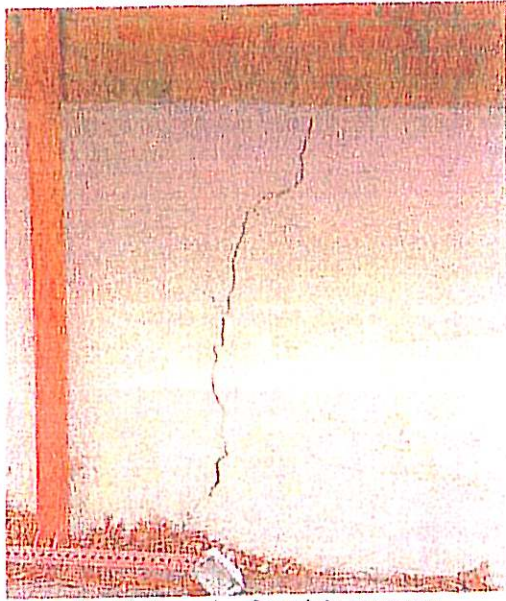
There are some cracks in the concrete basement walls. It was noted that the cracking in the concrete walls corresponds to the cracking pattern of the brickwork above.

Fig 20: Example of crack in concrete

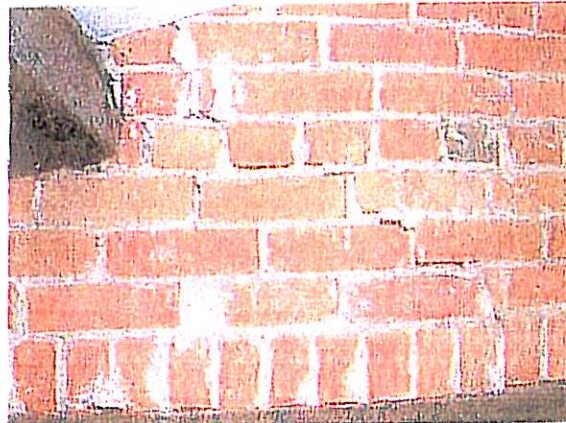
Fig 28: Cracking of Upper Level brickwork

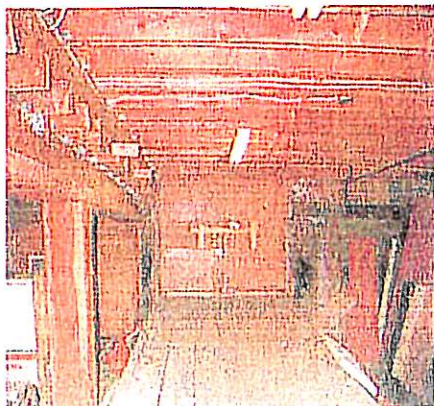
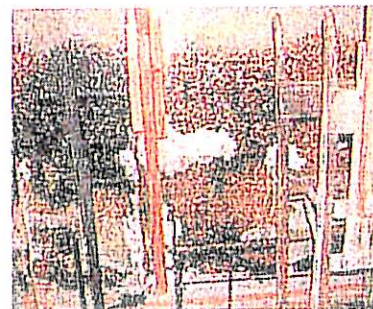
The walls are constructed in concrete with brickwork at higher level. In some areas the concrete have been covered with a bitumen based paint, traditionally used as a waterproofing coating. This is failing and there is a build-up of salts between the concrete and paint and a result of repeated wetting-and-drying cycles. This is to be expected in a basement and generally the condition of the walls is good. It was reported that a section to the south suffers from repeated water penetration, particularly after heavy rainfall. The condition of the brickwork above is good. There are internal partitions used for secure storage. These have been built within the past ten years and comply with all local building codes. There is a variation in ceiling height, the variation due to sections of Main Level floor joists being removed and raised. Pipes are exposed beneath the ceiling giving a lower ceiling height. Some ceilings are finished in drywall which has been fire rated. Many mechanical and electrical services enter the building at this level, and there are areas of penetration where the fire barriers have been damaged.

Fig 29 & 30: View of Lower Level. Removed floor joists (left) to facilitate additional headroom. Bitumen waterproofing material on walls (above).

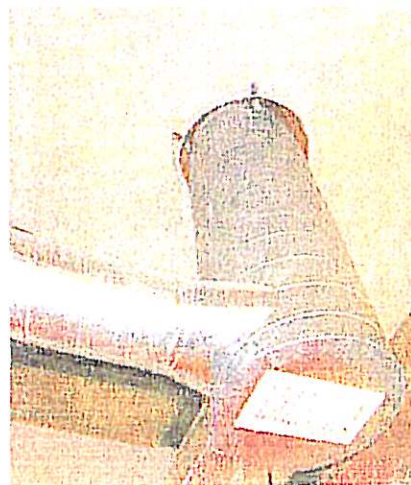
Fig 3 I: Example of penetration of fire partitioning between Main and Upper levels

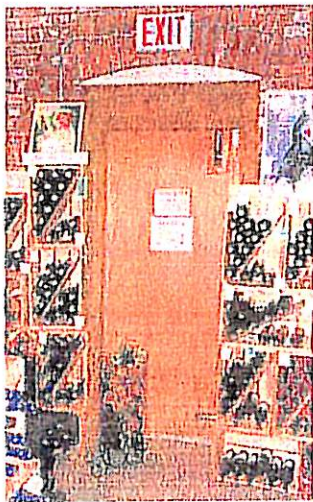
Fig. 32: Exit door blocked and incorrect panic hardware
