# WILDEN CONSTRUCTION CORP. CATTAIL POND MULTI-FAMILY DEVELOPMENT UPPER CANYON DRIVE ISSUED FOR DEVELOPMENT PERMIT OCTOBER 3, 2022

# Geohazard Assessment Report

## 225 Upper Canyon Drive North, Kelowna, BC

# Preliminary Geotechnical Assessment

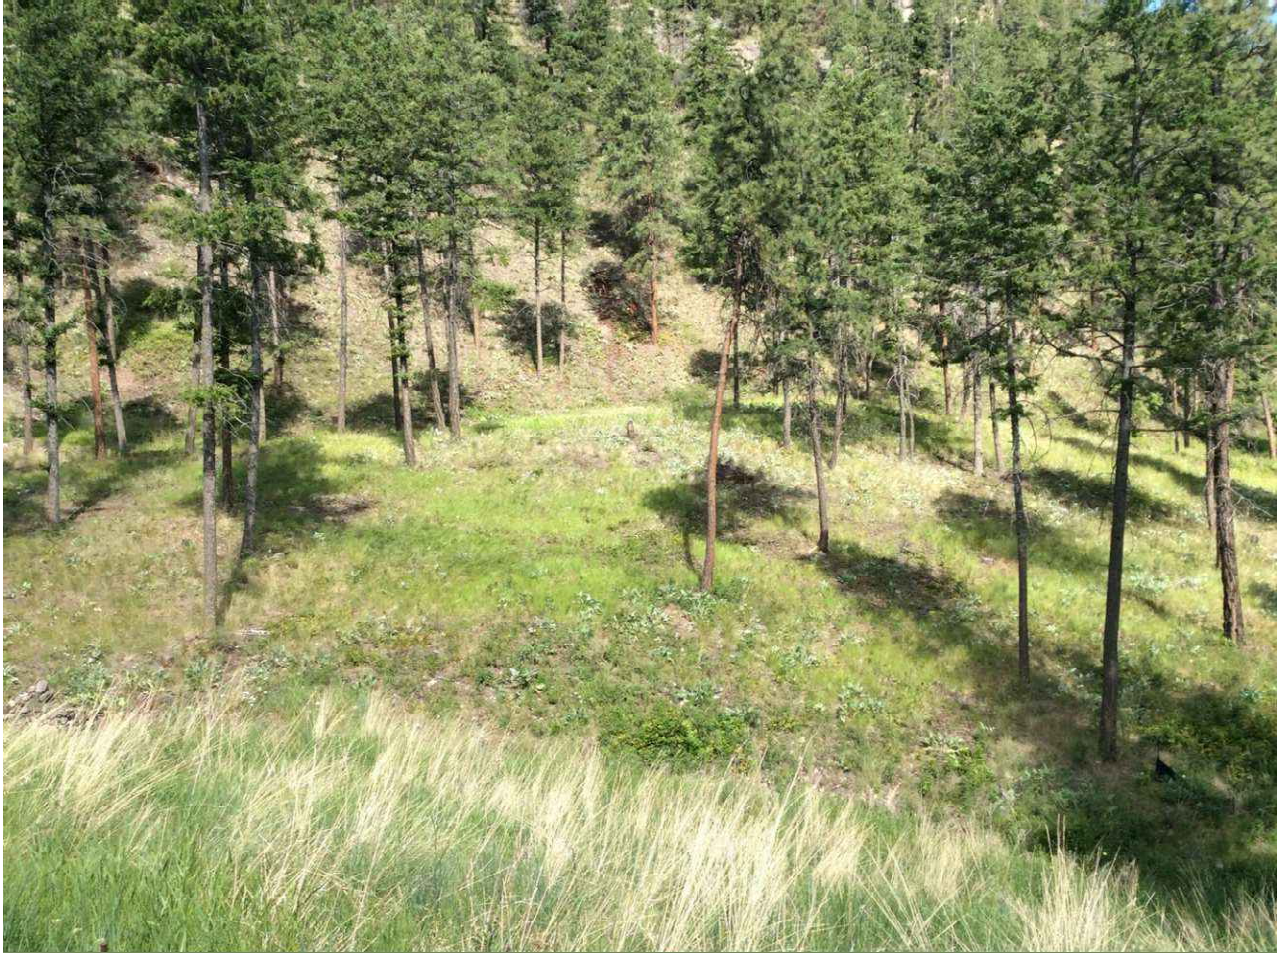
The historic aerial photos indicate that localized, small-scale landslides have occurred since 1938 but are predominantly confined to areas upslope of the Site. Colluvial and talus deposits were found to be contained by the benches created by glaciofluvial fluting along the bedrock. At the southern portion of the Site, there is a ‘mound’ at the base of the western slope that was not captured within the available historic air photo record; however, was observed during the site reconnaissance impacting the natural stream alignment. **Based on the observation of small-scale landslide events between 1938 and 2006 in the historical imagery review, the probability for future events to occur is considered high for the general Wilden area. The probability for events impacting development at the site is variable depending on the location and scope of construction. Risks associated with small scale landslide events must be assessed during the detailed design phase for each proposed construction lot within the site.**

**Photo 5.1a: Facing West from the southeast corner of the site to the ‘mound’ identified during field reconnaissance. The mound pre-dates the historical photo review (1938-2020). (Placemark 3, 2021-06-09)**

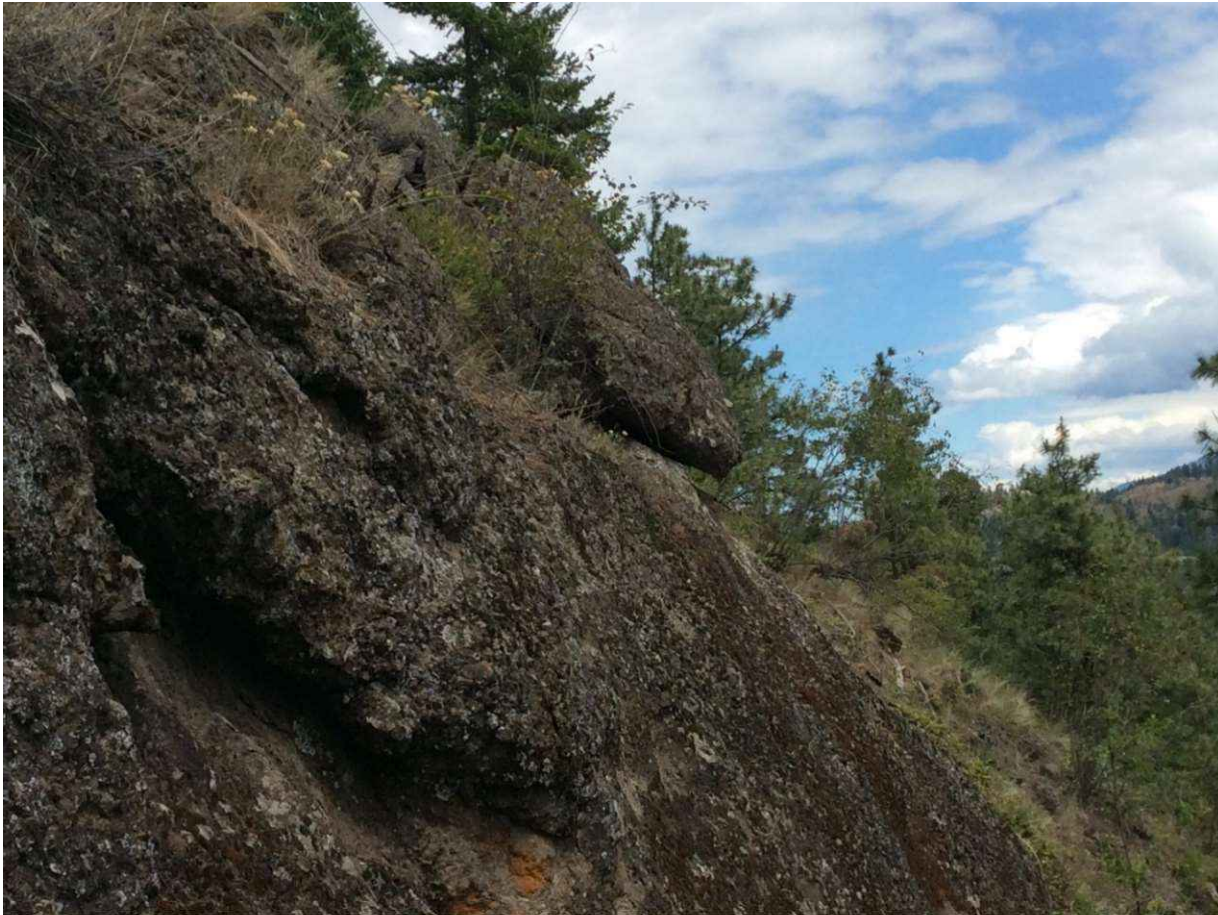
Rock fall debris was observed during the site reconnaissance scattered along the western slope and talus slopes were observed within the rock fall shadow zone (see Figure 4.1) below inferred bedrock crests and bedrock outcrops. The talus deposition observed across the site is variable in age inferred by the relative overgrowth of vegetation and moss. Areas lacking vegetation and moss are indications of more recent movement events than areas overgrown, and moss covered. **Based on the observations on site and the historical imagery review, the estimated overall probability of rock fall hazard events vary, ranging from negligible to high risk of occurrence depending on the location. Rockfall protection measures must be assessed and implemented**

Photo 5.1b: Detached boulders and jointing were identified on bedrock exposures on the west slope above the 'mound' identified on the south end of the site. (Placemark 9, 2021-06-09)

on a site-specific basis for each proposed development structure. Mitigation designs must be developed based on the local risk and scope of the construction during the detailed design phase of the project.

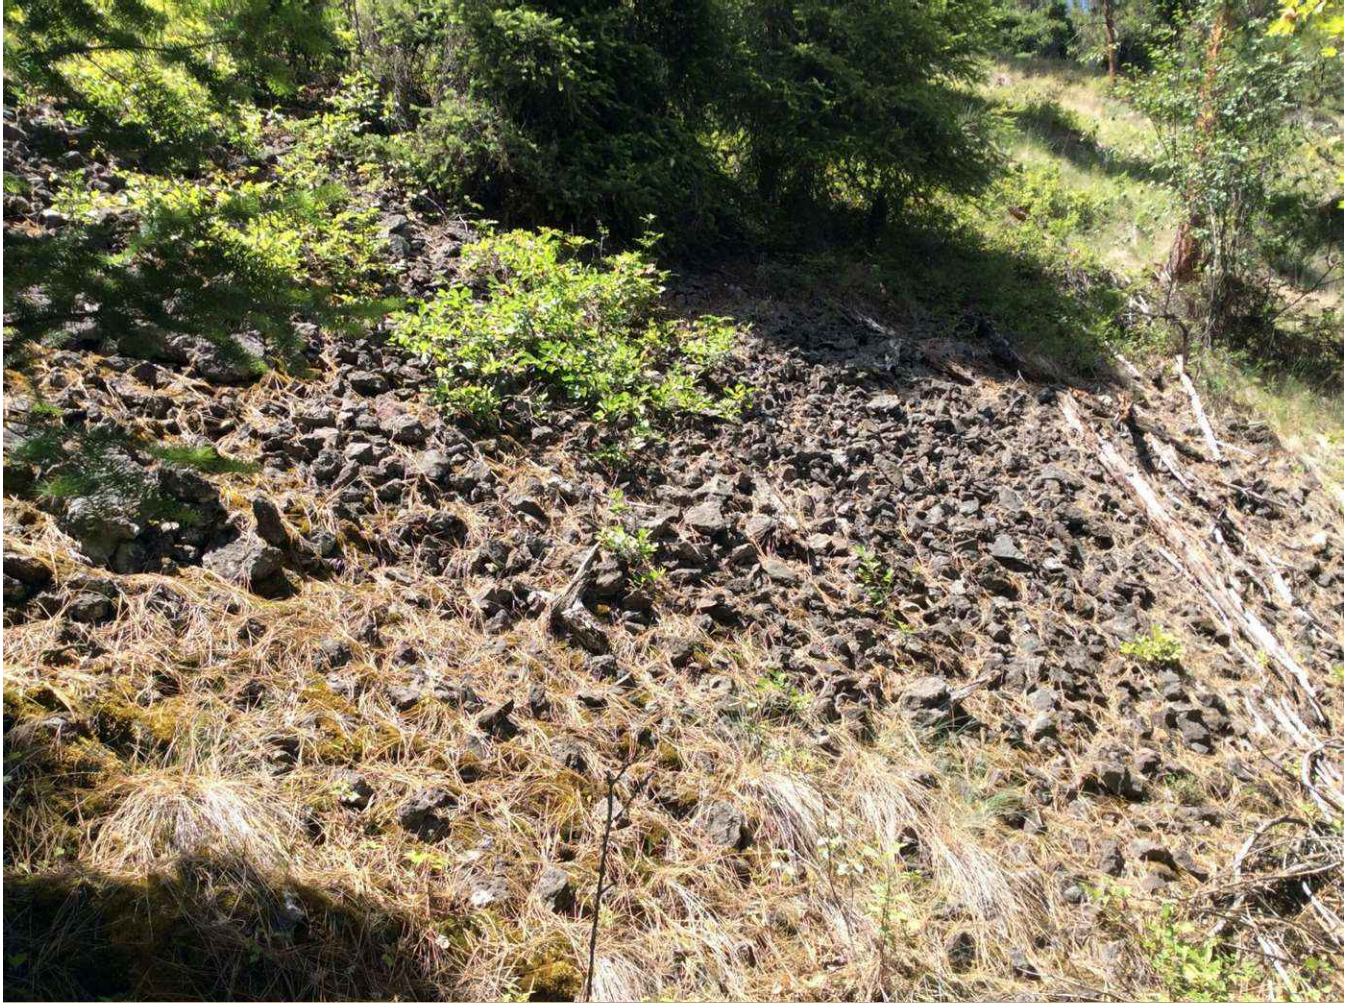
- The lowest elevation bench above the northern portion of Site (Placemark 12) contained a rockfall reach angle of approximately 34°, and a rock fall shadow angle of about 32°. A historic rockfall zone was observed containing younger trees upslope, flanked by talus slopes, and cobbles with occasional boulders scattered along the bench below the assumed rockfall zone.

**Photo 5.1c: Talus was identified along the west slope above the site as well as at the toe of the slope along the west perimeter of the site. (Placemark 12, 2021-06-09)**
