REPORT TO COUNCIL

Date: July 31, 2012
To: City Manager
From: Land Use Management, Community Sustainability (GS)
Application: DP11-0103 **Owner:** Thomas Greenough
Sandra Greenough
Address: 250 Lochview Road **Applicant:** Arda Consultants Ltd.
Subject: Development Permit - Natural Environment/Hazardous Conditions

Subject Property Map: 250 Lochview Road, Kelowna, BC

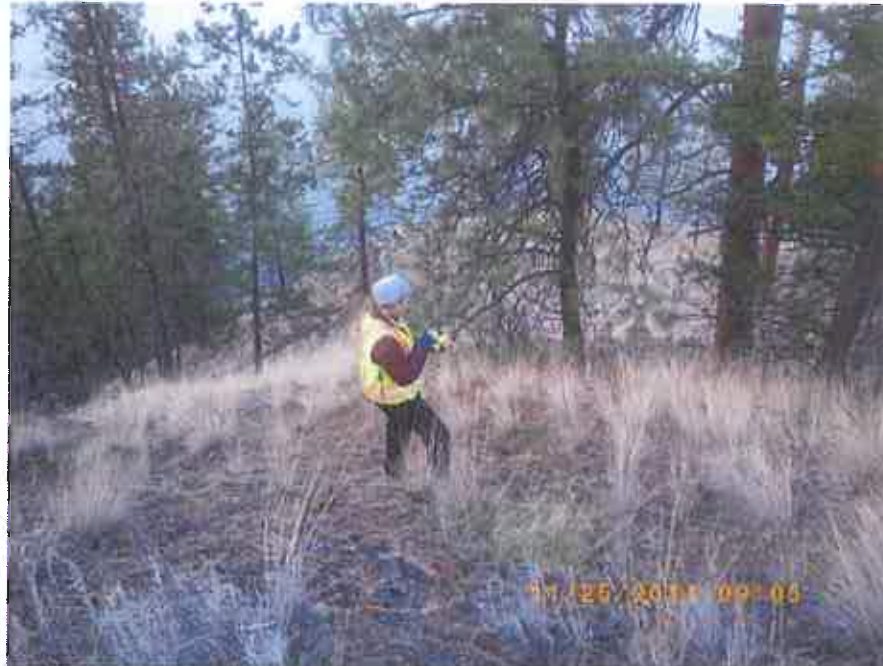
Photo 1: Depicts the open woodland and grassland communities with shallow soils and exposed rock typical of the subject property.

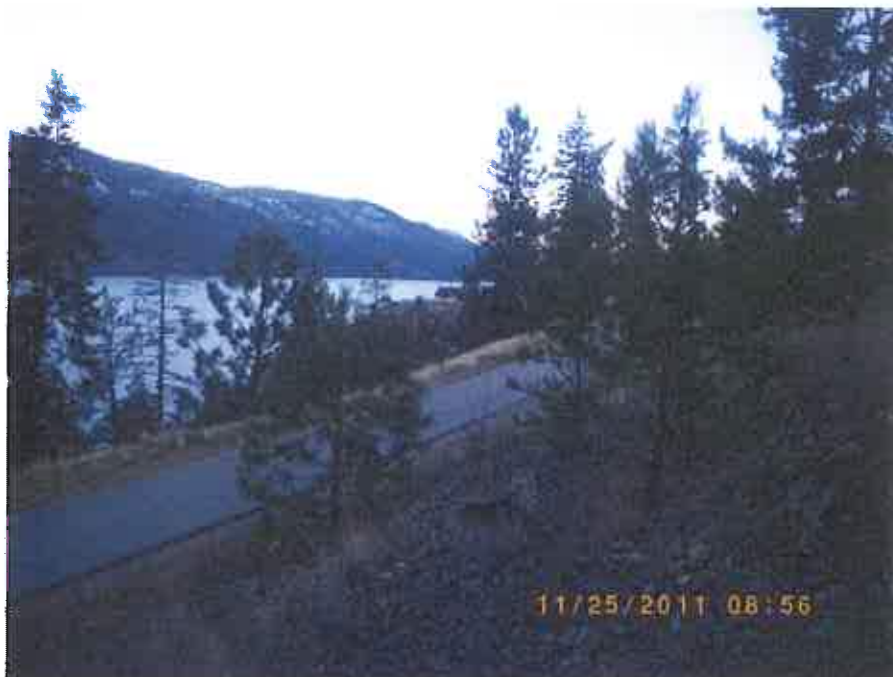
Photo 2: View of the proposed cut location (turnaround) located on the eastern side of Lochveiw Road.

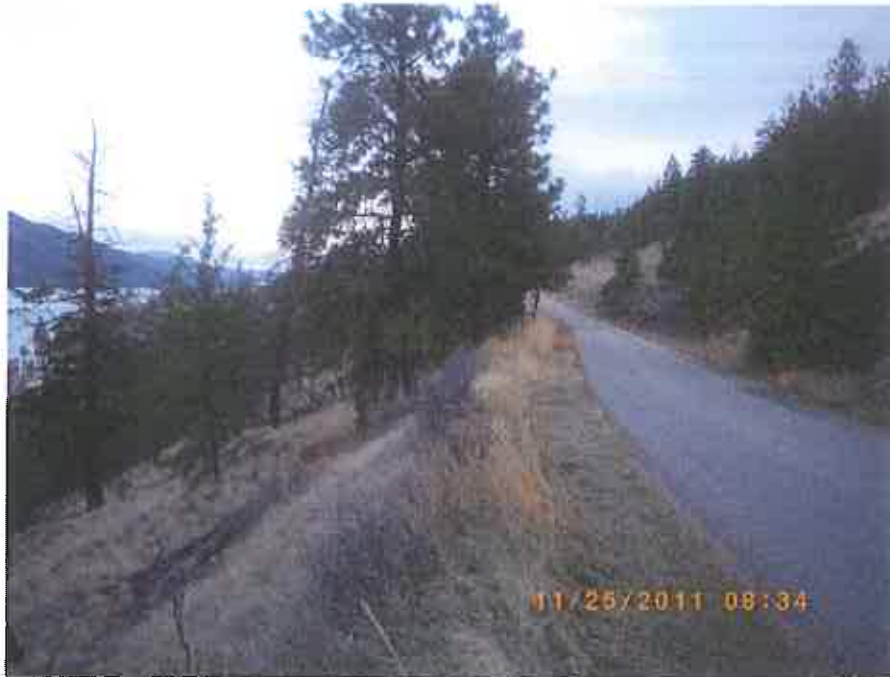
Photo 3: View of the detached garage footprint adjacent to Lochivew Road, three trees will need to be removed in this area (November 25, 2011).

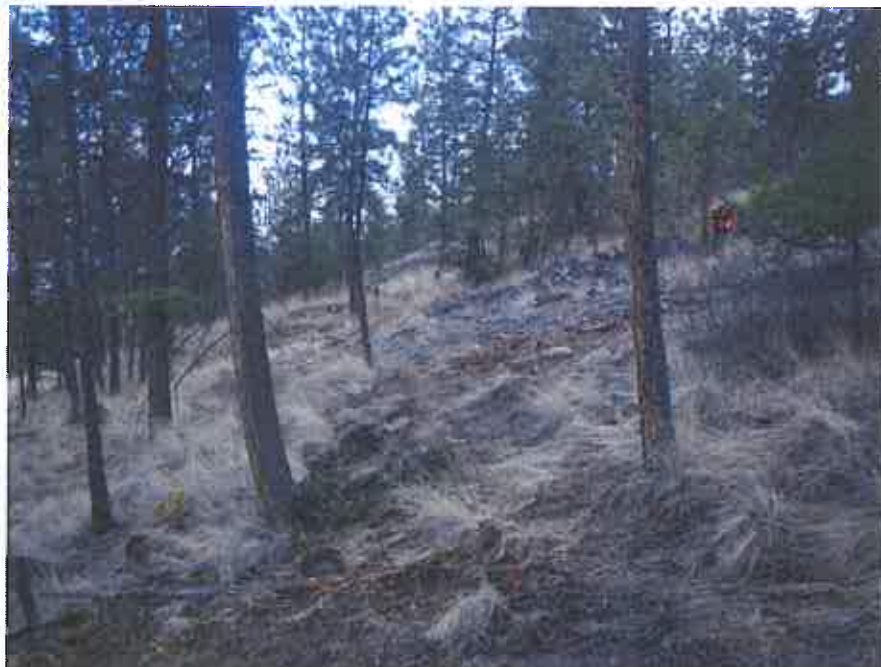
Photo 4: View of the septic system footprint, eight trees will need to be removed in this area (February 3, 2012). Note the disturbance and stockpiles of woody debris.

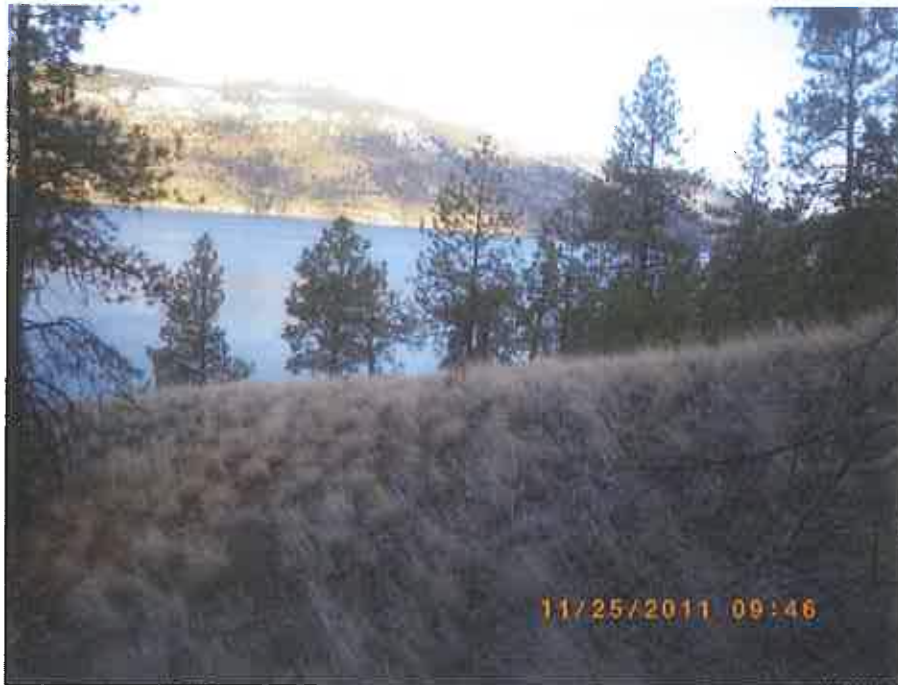
Photo 5: View of the house footprint which is located on a relatively flat terrace of the subject property (November 25, 2011).

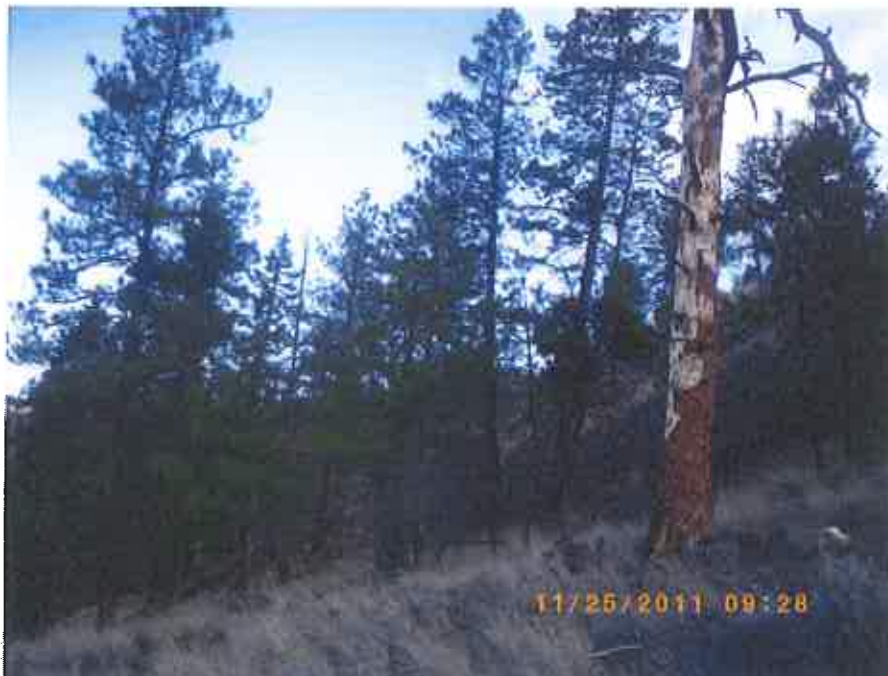
Photo 6: View of a large snag tree located within the house footprint (November 25, 2011).

- For the high value snag that occurs within the footprint of the residence, Ecoscape recommends that this tree be carefully felled and if possible utilized elsewhere within the subject property. Ecoscape understands that the Property Owner has access to specialized equipment (e.g. cranes), which will allow the snag to be repositioned to within 25 m of existing access roads. The following are recommendations pertaining to the re-use of the snag:

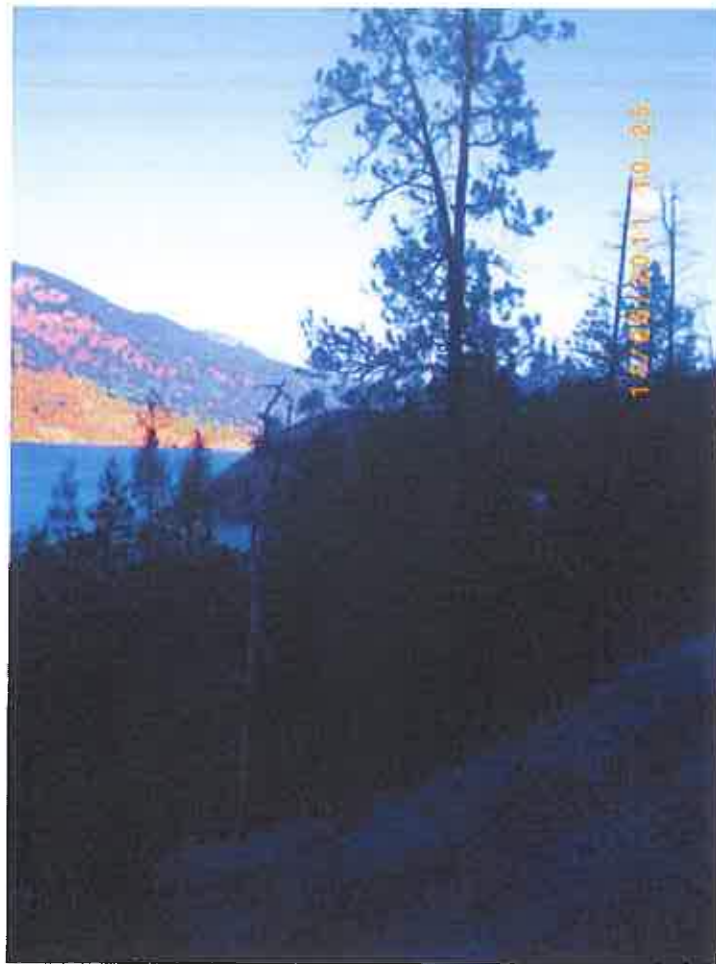
Photo 7: View of a mature Ponderosa pine and large snag located within the proposed house footprint (November 25, 2011).

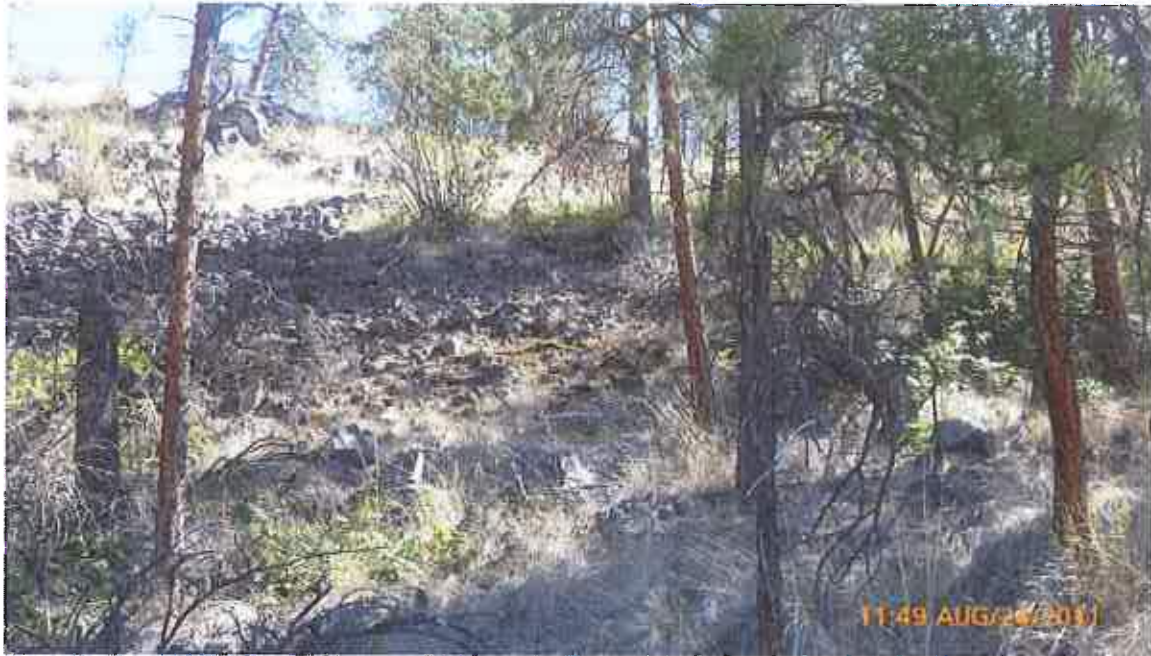
Photo 8: View of the rock talus slope located to the east of the proposed house footprint (August 24, 2011).

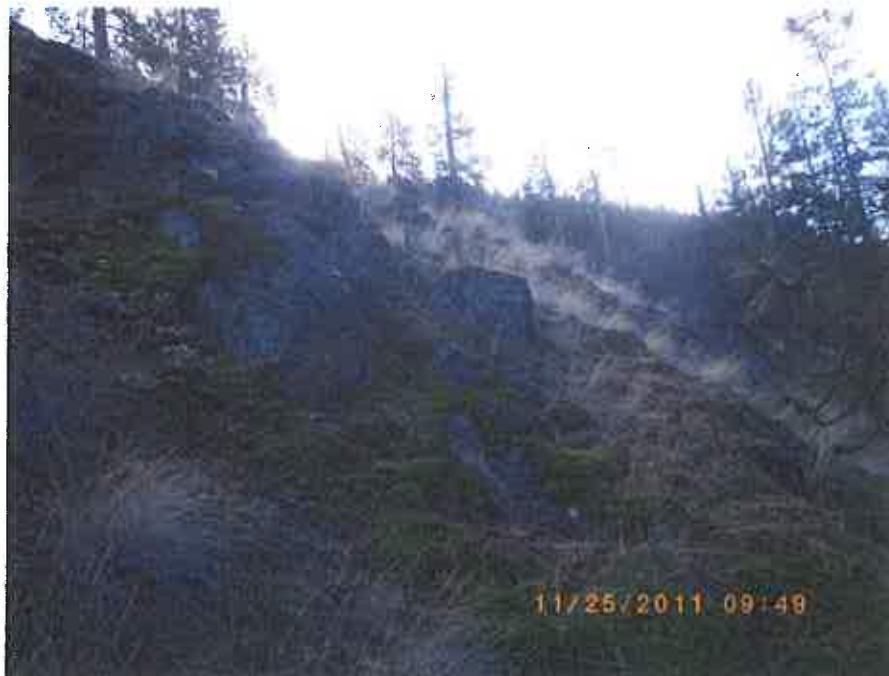
Photo 9: View of exposed bedrock located to the east of the proposed house footprint (November 25, 2011).

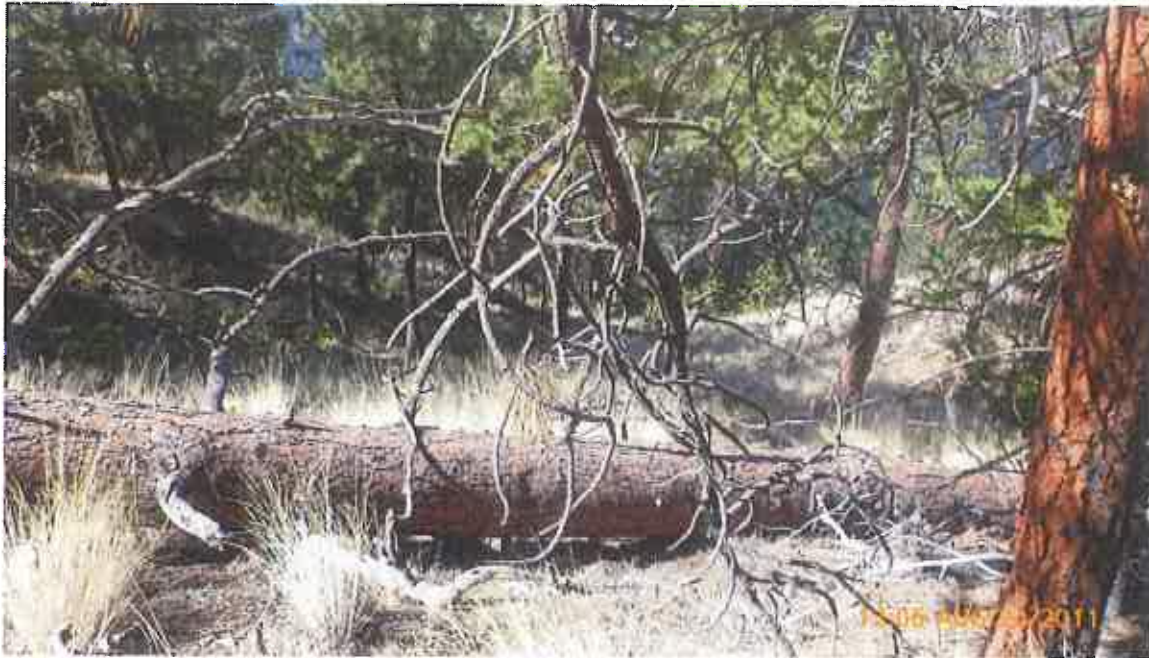
Photo 10: View of the steep gully that the proposed driveway alignment will traverse (August 24, 2011).

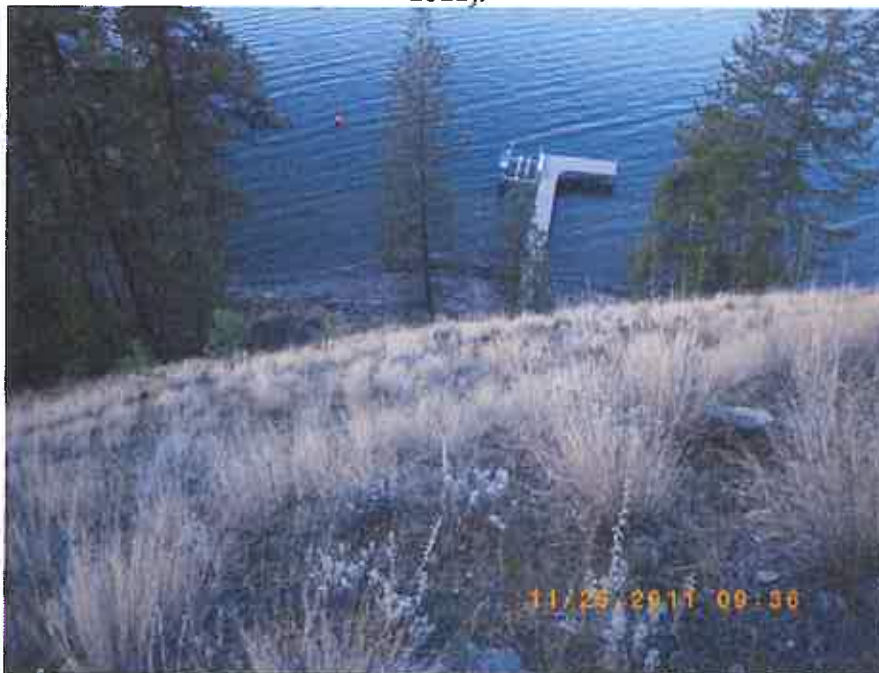
Photo 11: View of proposed tram footprint (November 25, 2011).

The tram is ~ 85m in length and will have a footprint of ~ 255 m² and may require the loss of a few shrubs but removal of mature trees is not proposed. The tram track system will be open and will not preclude the re-establishment and growth of shrubs and ground cover vegetation beneath. The following recommendations are proposed for the tram development;

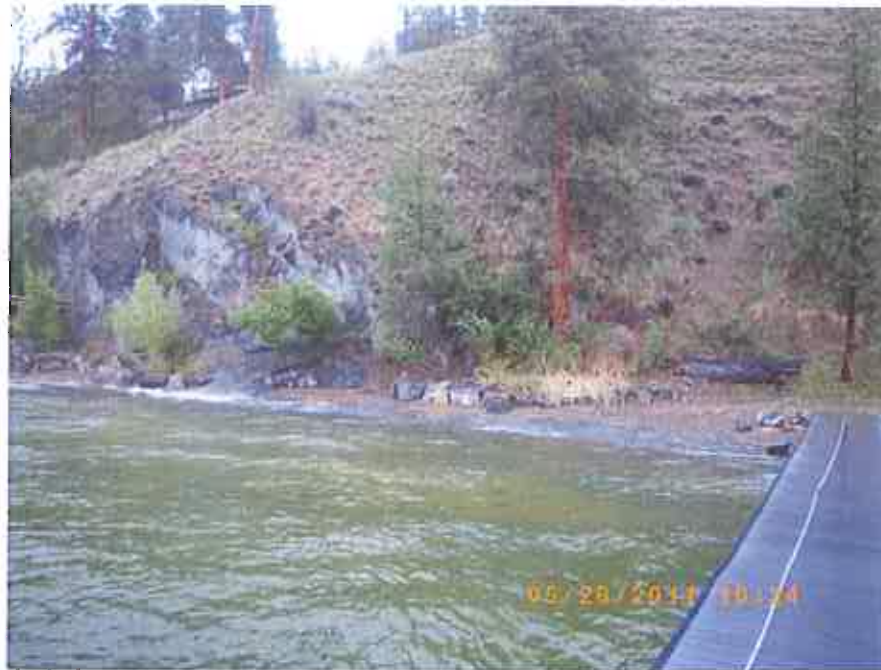
Photo 12: Depicts some of the native vegetation that occurs along the foreshore (May 26, 2011).

part of the shoreline. At the time of the May, 2011 site assessment native riparian vegetation included Ponderosa pine, interior Douglas fir, rocky mountain juniper (*Juniperus scopulorum*), tall-Oregon grape, Saskatoon, common snowberry, common rabbit-brush, alder (*Alnus* sp.), rose (*Rosa* sp.), arrow-leaved balsamroot, pasture sage, pinegrass (*Calamagrostis rubescens*), and giant wildrye (*Elymus cinereus*), with red-osier dogwood (*Cornus stolonifera*), willow (*Salix* sp.), and scouring-rush (*Equisetum hyemale*) limited to the foreshore (Photo 12).

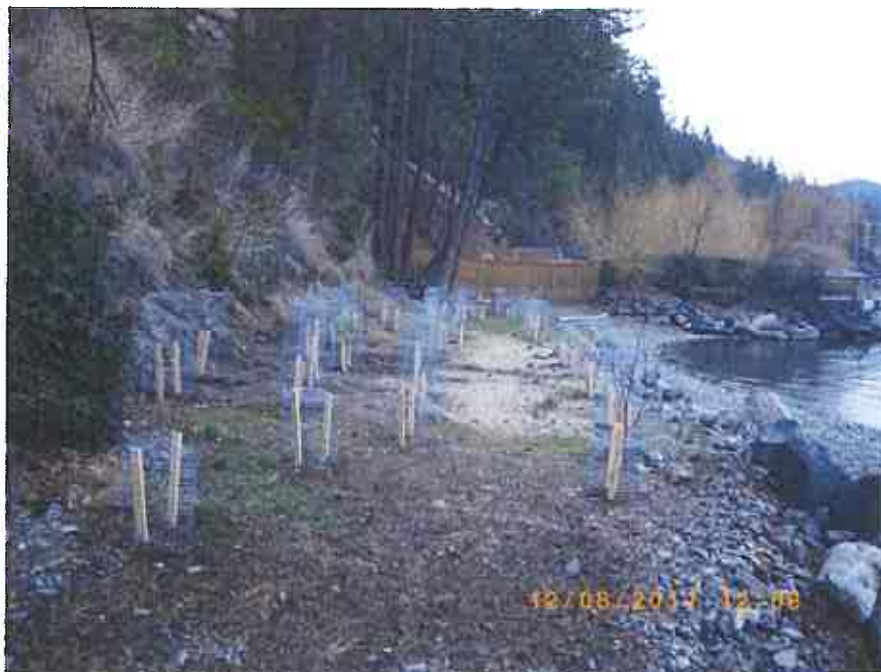
Photo 13: View of restoration that occurred subsequent to the removal of a cabin and gazebo from the riparian area in August, 2011. Plantings were complete in October, 2011. (December 8, 2011).

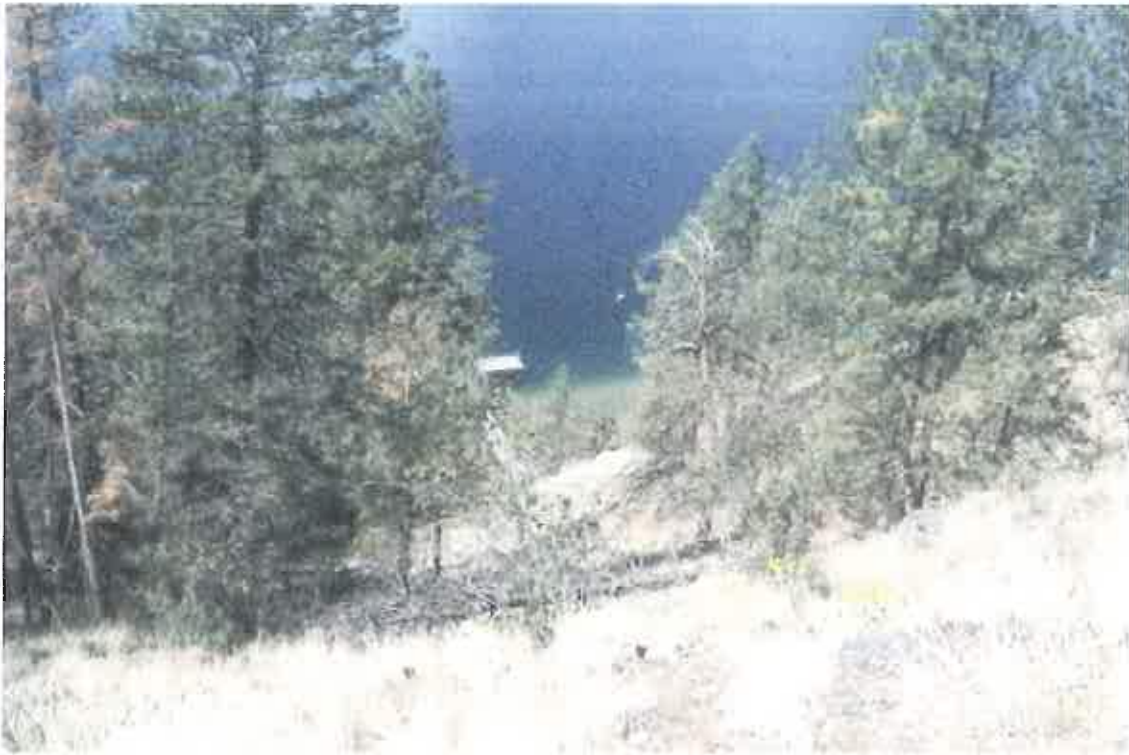
Ladder fuels should be removed or reduced in height; the minimum being 2.5m between ground fuels and lower branches.

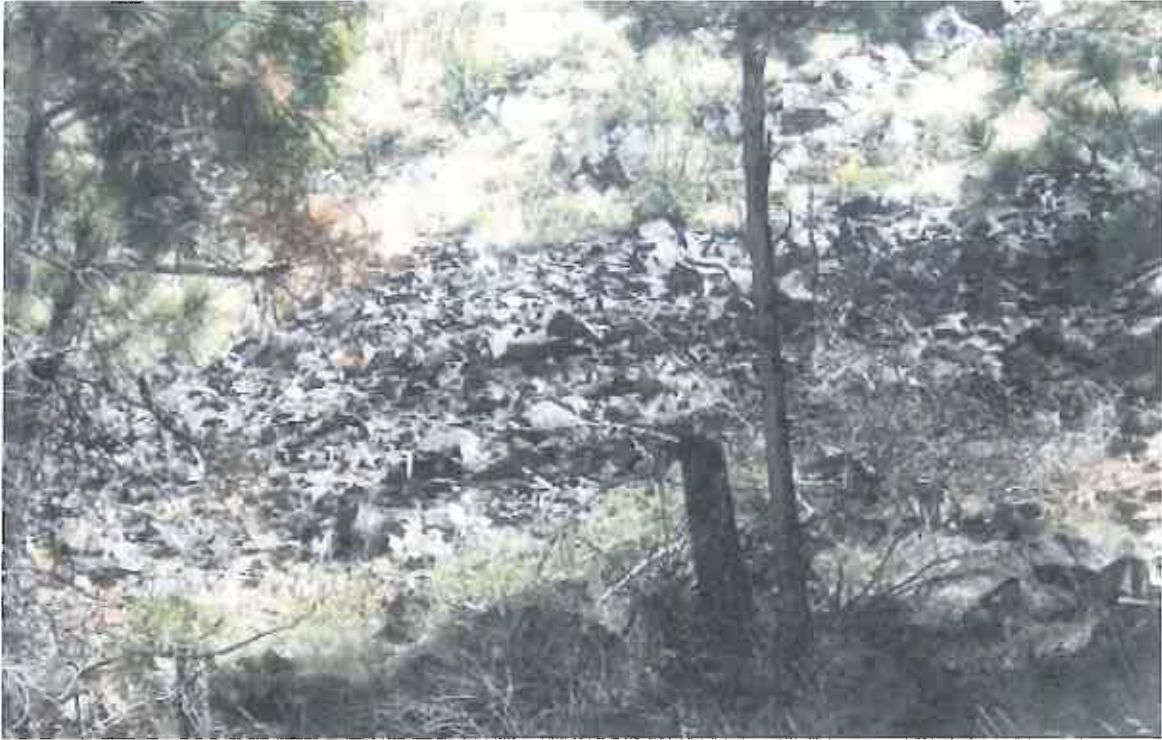
Talus slope above proposed building site

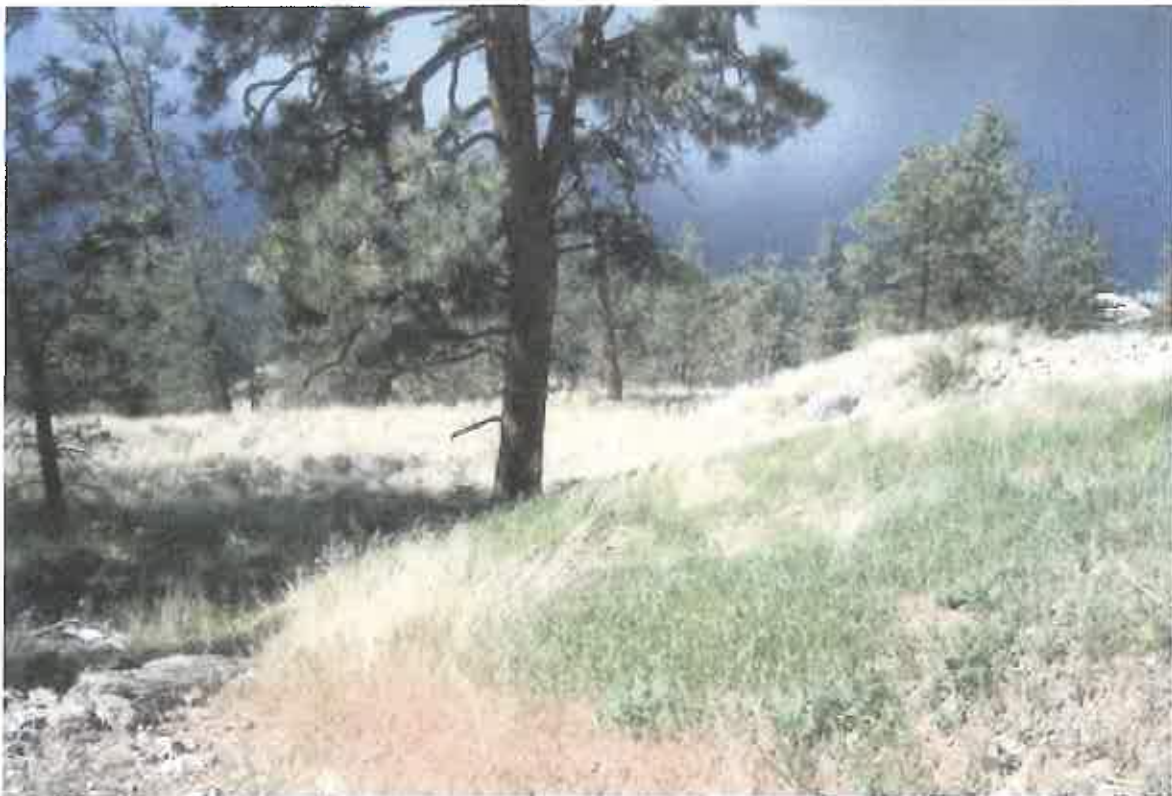
Mature ponderosa with natural lower branch loss, large open area thin duff = low fire potential

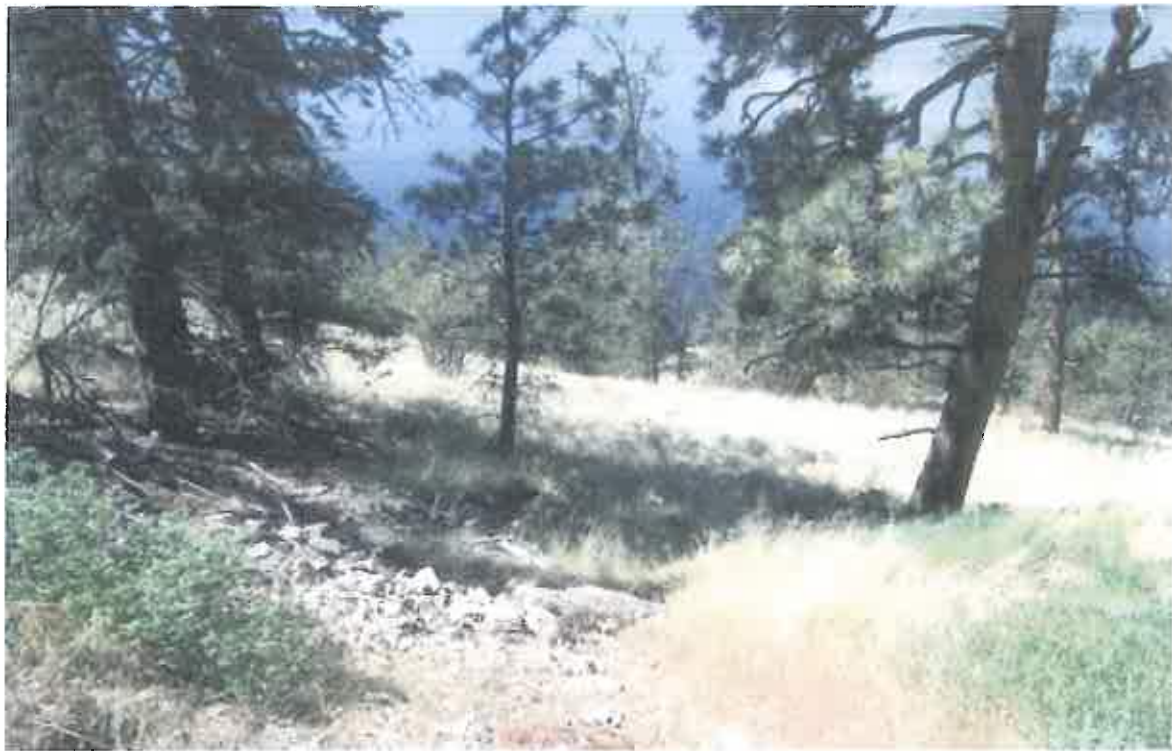
Paired mature ponderosa, ladder and ground fuels = high fire potential

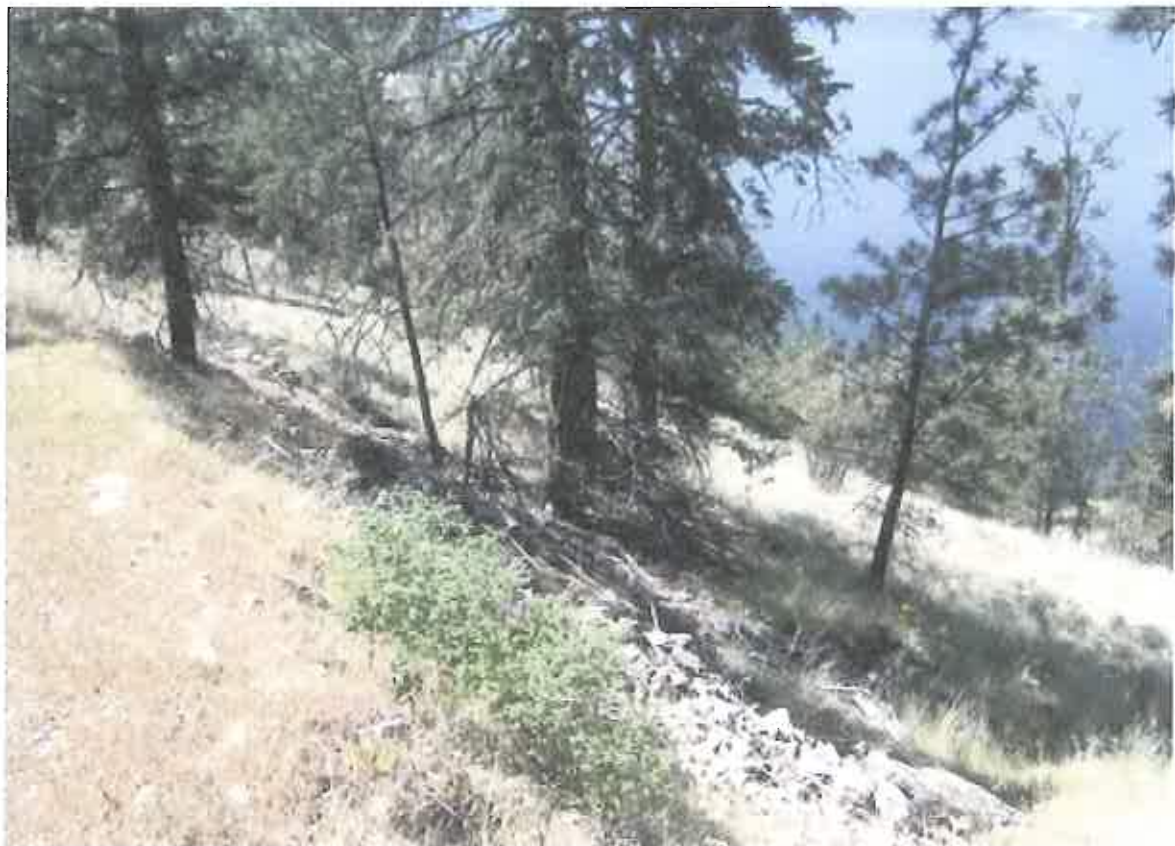
Paired mature ponderosas, ladder and ground fuels = high fire potential
