ENVIRONMENTAL ASSESSMENT

3215 HALL ROAD, KELOWNA, BC

PROJECT NO.: 291-01E

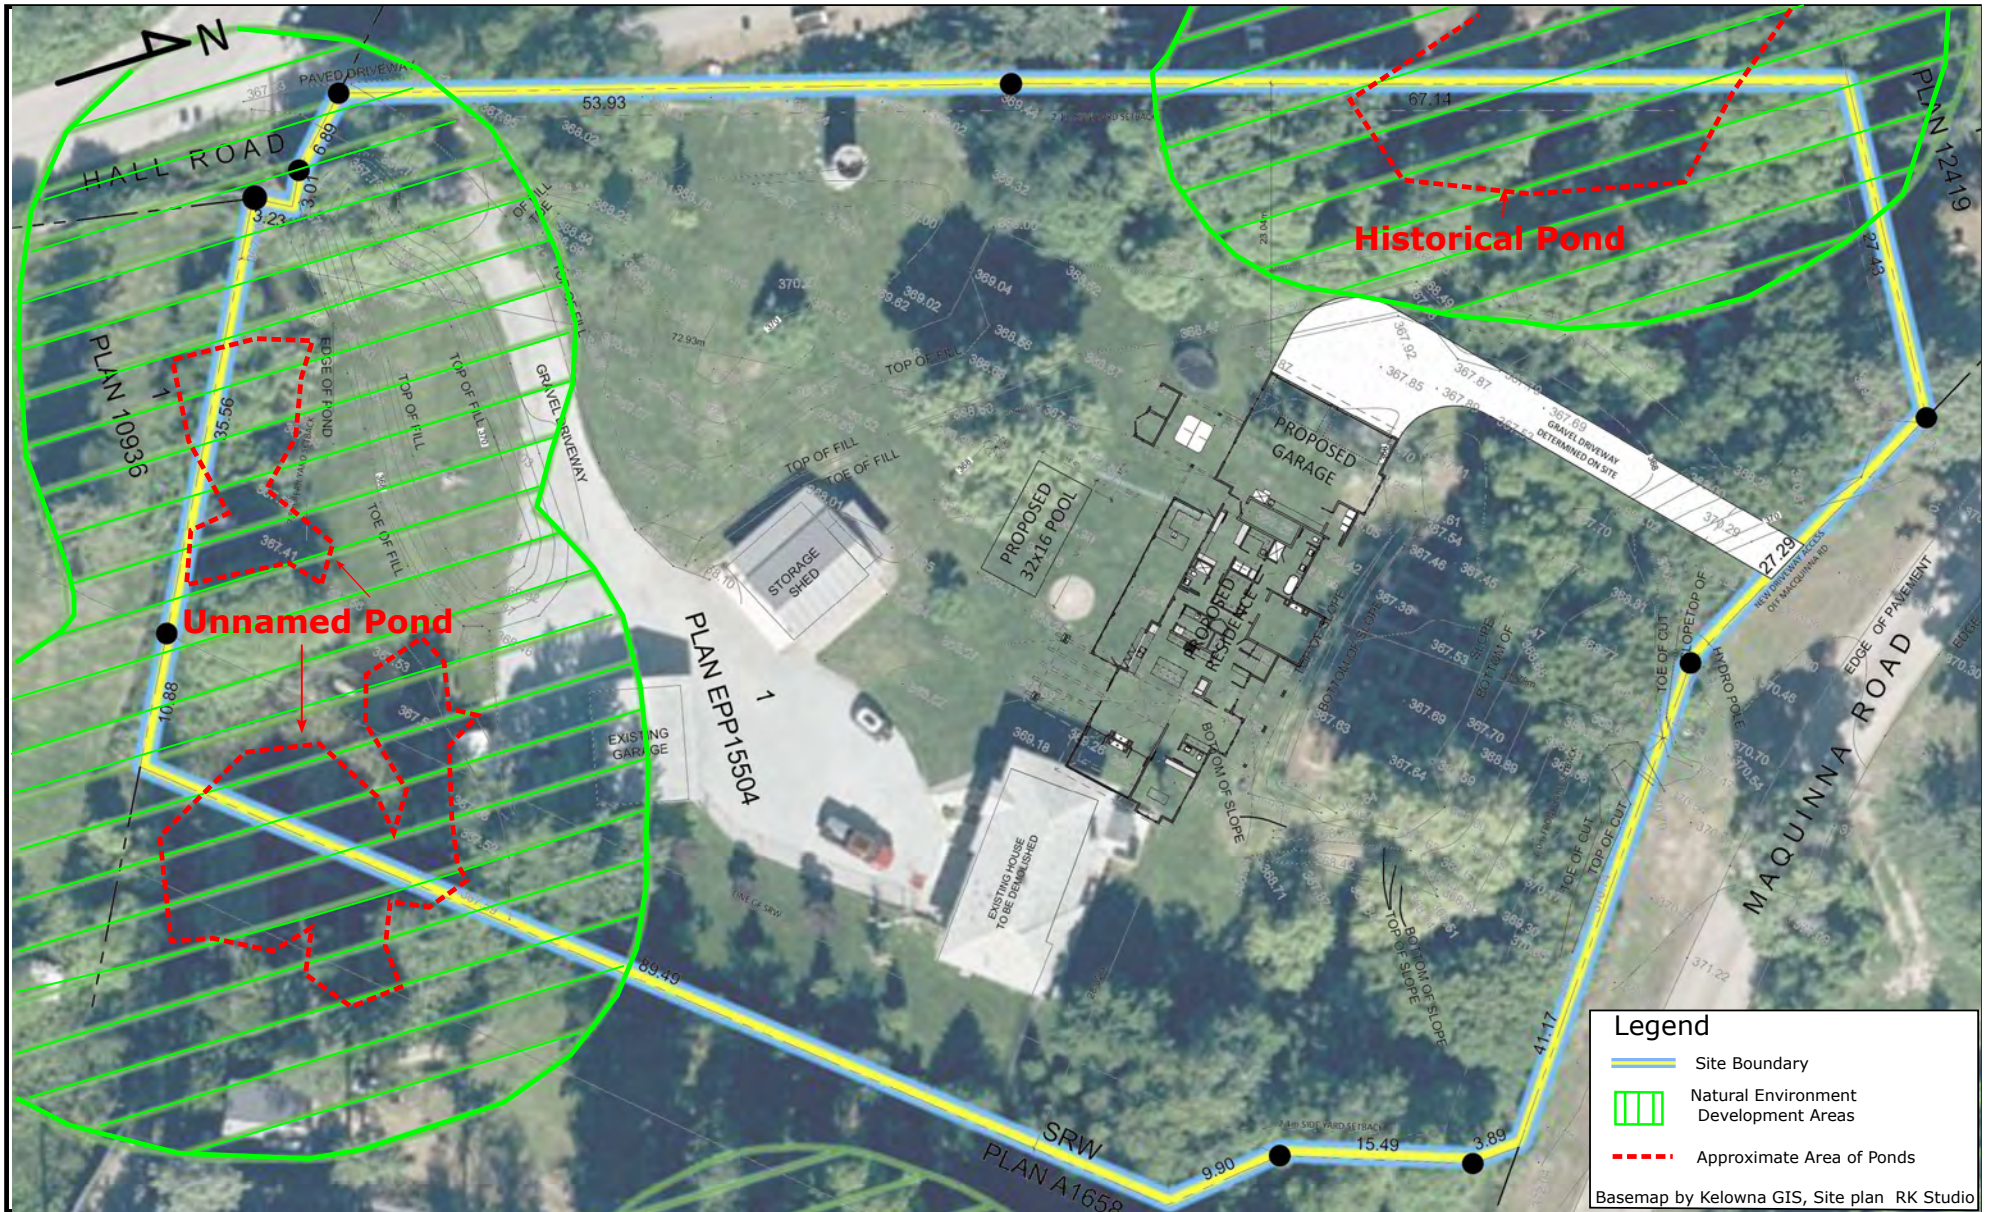
The Client is interested in re-developing the Site to accommodate a new single-family home. Based on the GIS, The Site is within the Wildland Fire Hazard Development Permit (WFH DP) area, and a portion of the north and south of the Site are within a Natural Environment Development Permit (NE DP) area. The Site entrance is paved and is located near the Unnamed Pond. **Figure 1** presents a Site plan with the current and proposed developments.

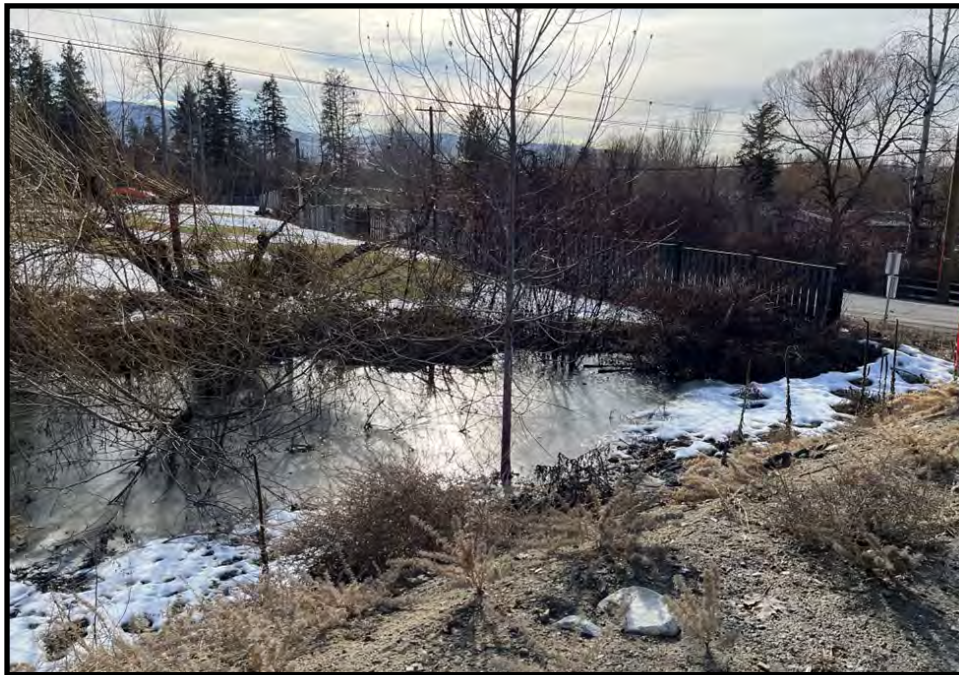
Photograph 1: Looking west, viewing the Unnamed Pond and the Site entrance from Hall Road.

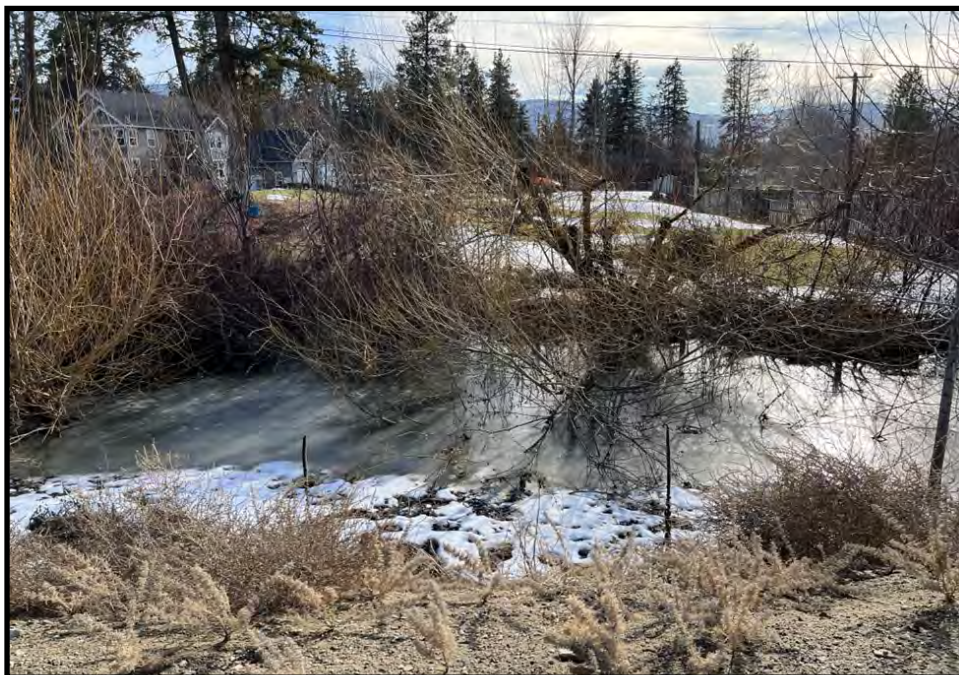
Photograph 2: Looking south at the Unnamed Pond and the neighbouring property south of the Site.

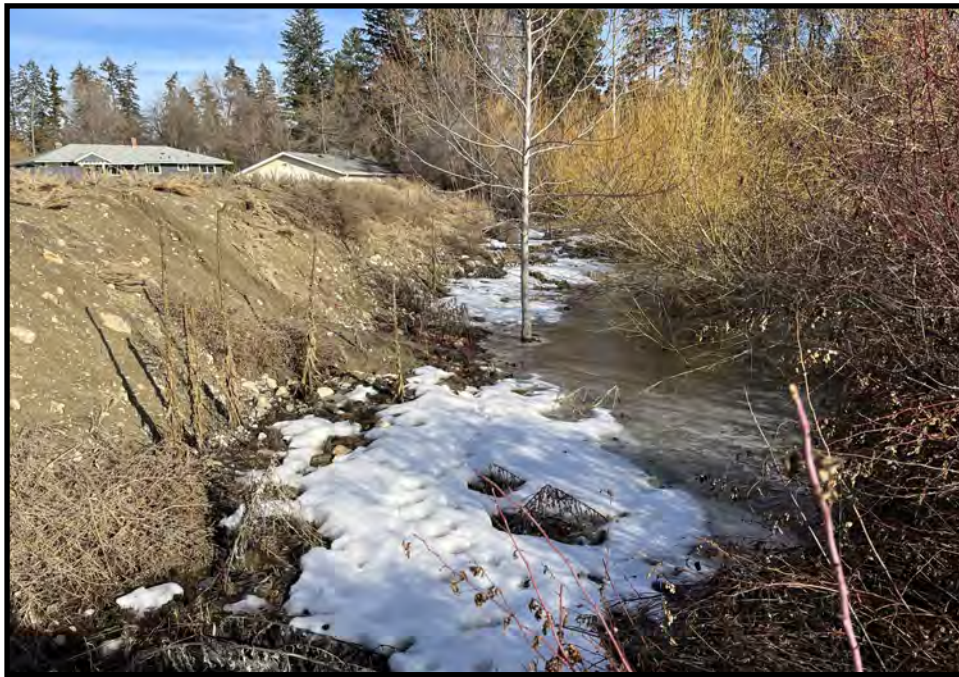
Photograph 3: Looking east at the Unnamed Pond and the fill bordering north of the pond.

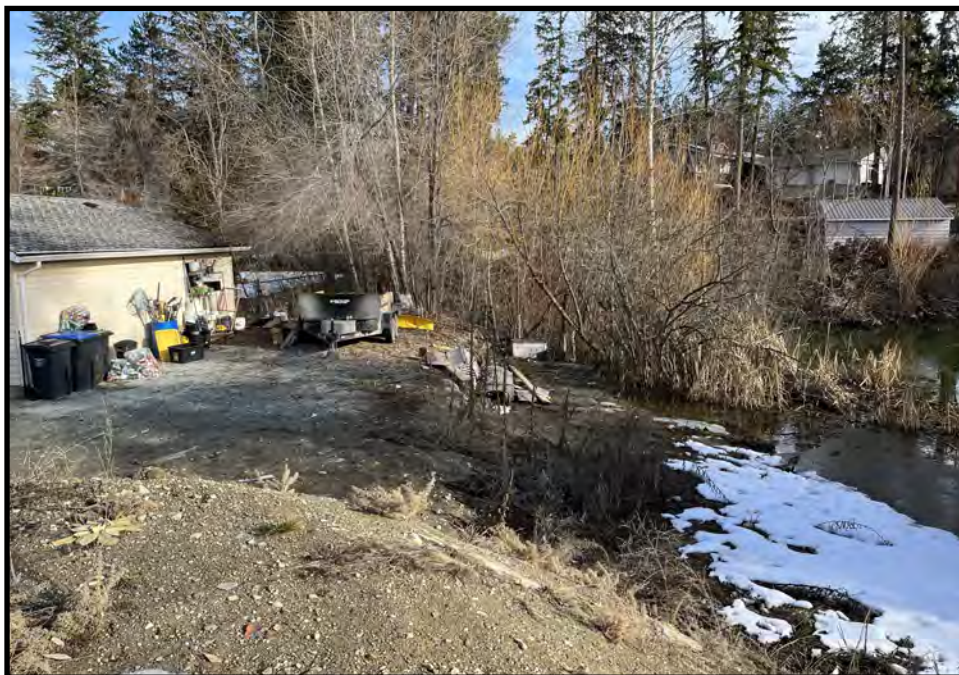
CSR attended the Site on February 15, 2023 and measured the distance of the existing garage to be 8 m and 7.4 m from the high-water mark from its west and eastern corners of the Unnamed Pond respectively. CSR also noted that the depressed area, which was formally the Historical Pond north of the Site was dry and overgrown with dense vegetation shrubs and trees. Site photographs with descriptions are presented in **Appendix II**. Historical aerial photographs presenting the Unnamed Pond and the Historical Pond are included in **Appendix III**.

Photograph 4: Looking east at the garage and the edge of the Unnamed Pond.

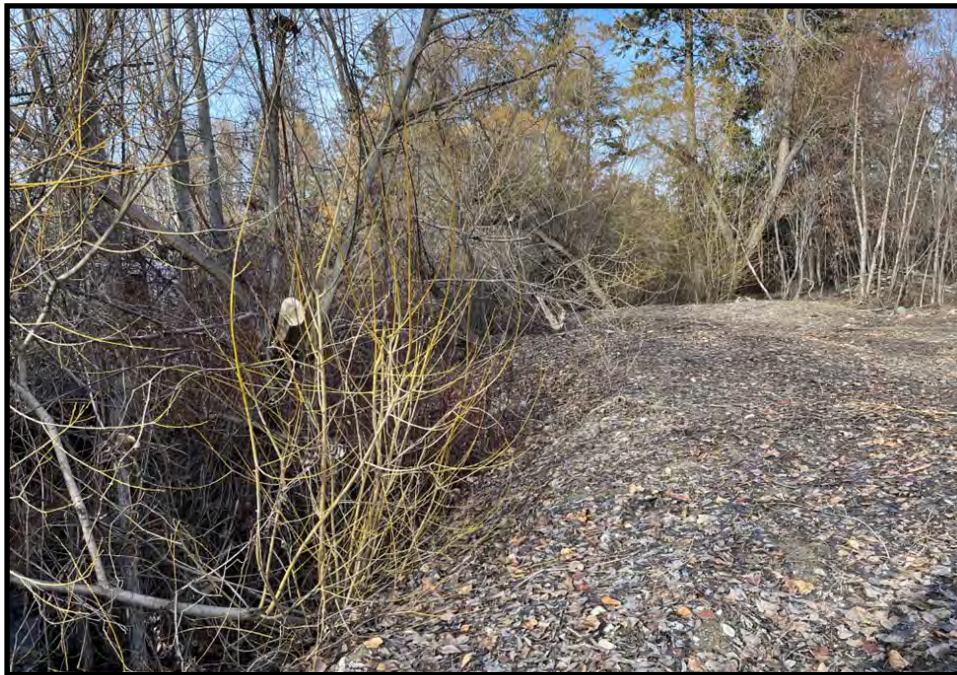
Photograph 5: Looking north at the Historical Pond area currently dry and covered in dense vegetation.

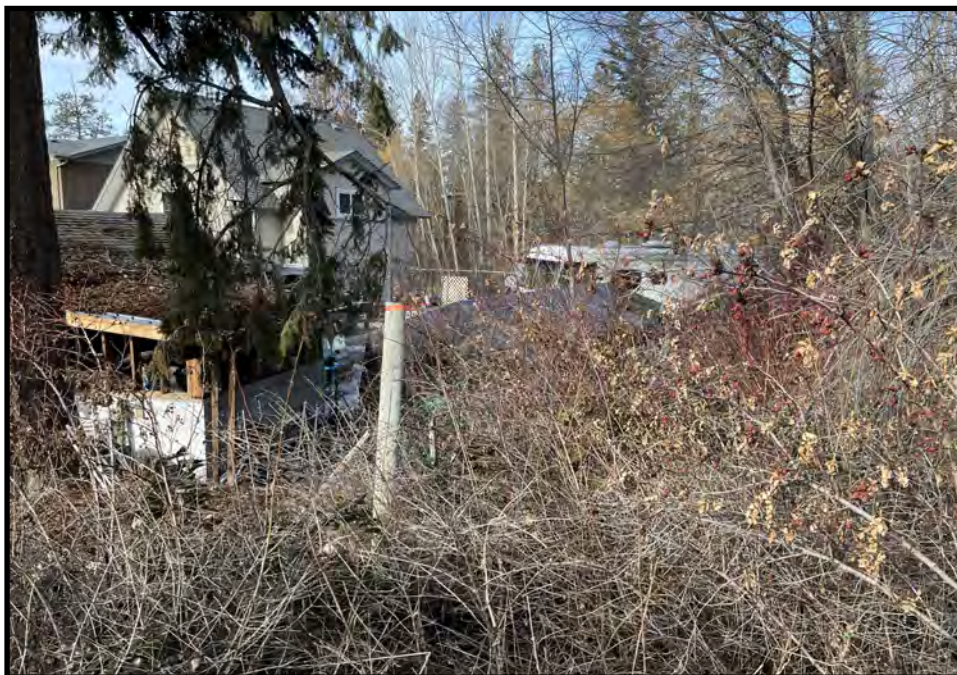
Photograph 6: Looking west at the Historical Pond area currently covered in dense vegetation and at the neighbouring property west of the Site.

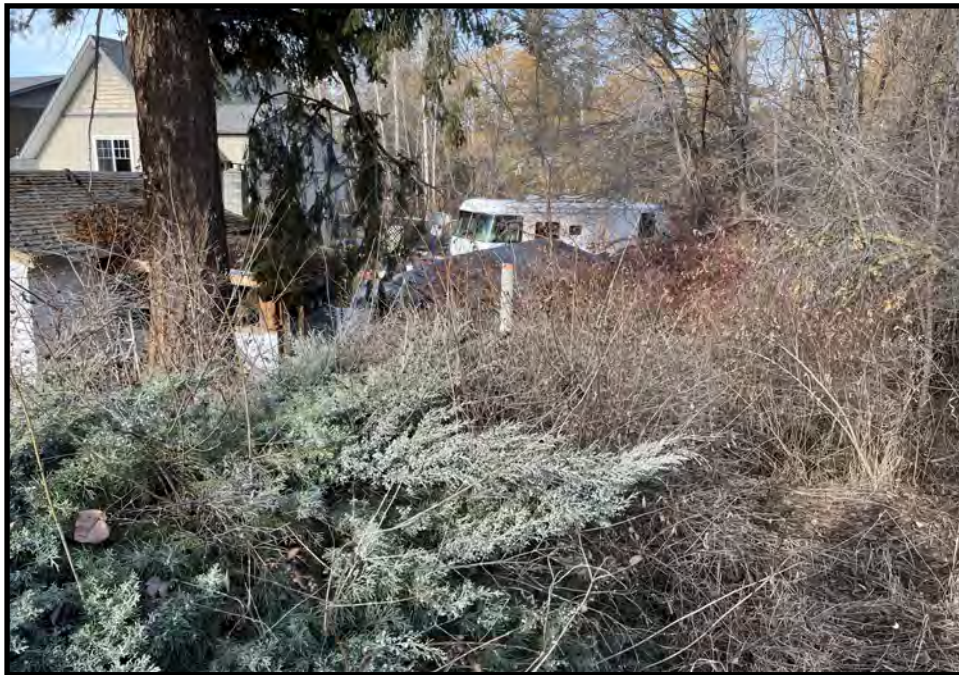
Photograph 7: Looking northwest at the Historical Pond area currently covered in dense vegetation and at the neighbouring property west of the Site.

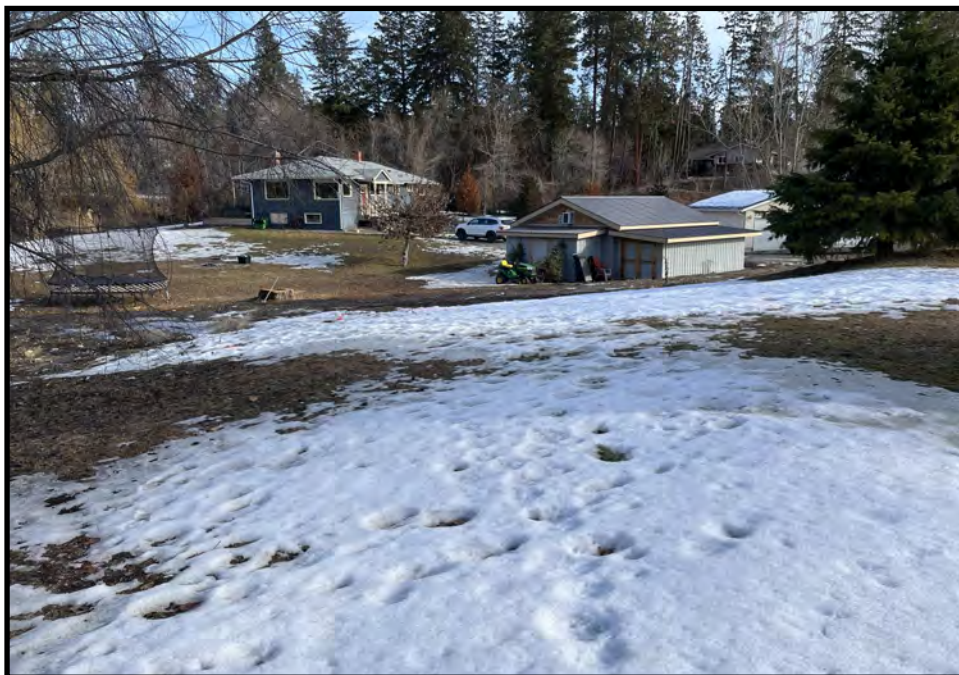
Photograph 8: Looking southeast at the proposed development area, currently occupied by a trampoline and fire pit, and the current house, storage shed, and garage.

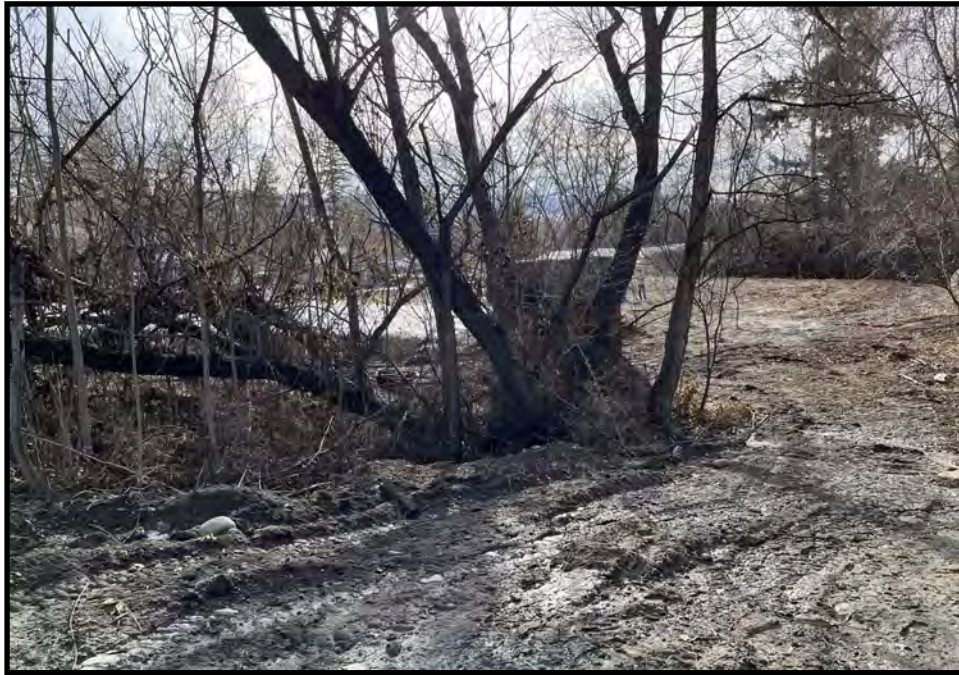
Photograph 9: Looking south at the proposed gravel driveway.

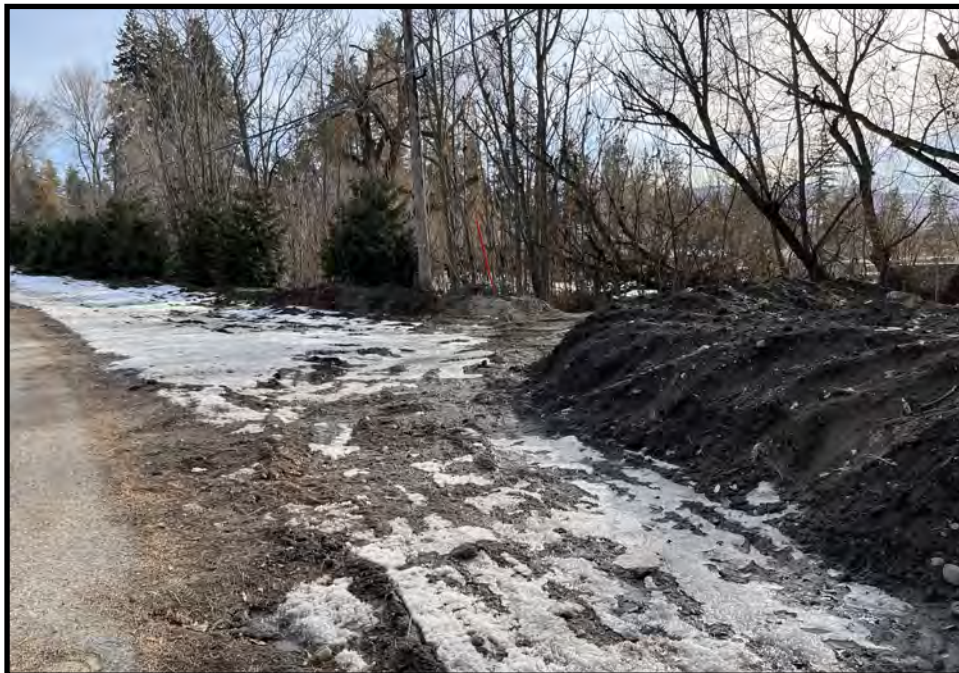
Photograph 10: Looking east at the proposed entrance of the gravel driveway from Maquinna Road.

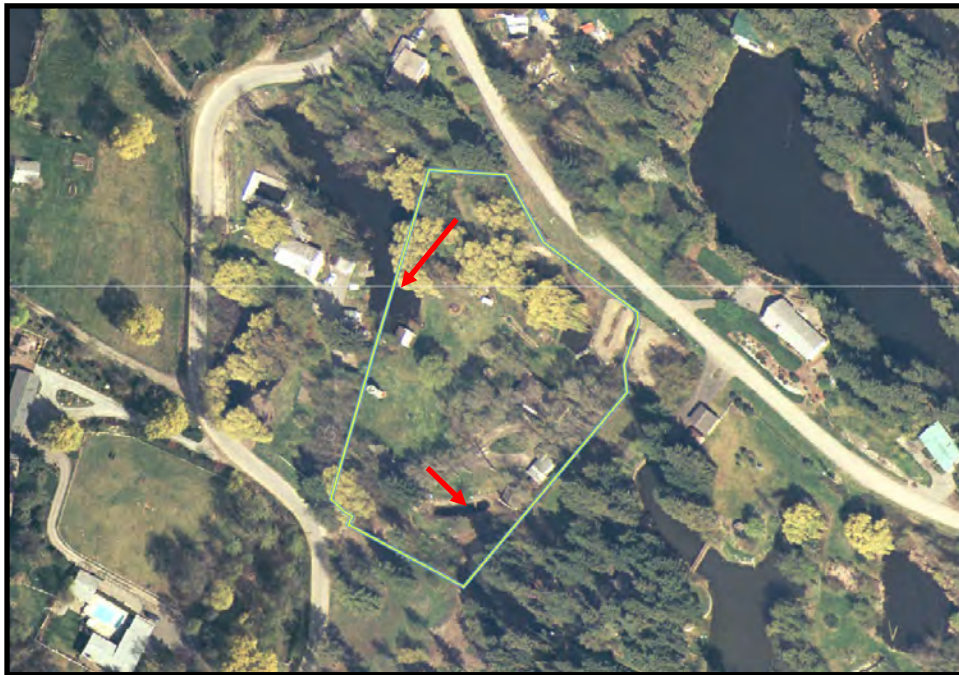
Photograph 1: Aerial photograph of the Site in the year 2000, a pond is shown to the northwest of the Site and to the southeast (Arrows indicate ponds).

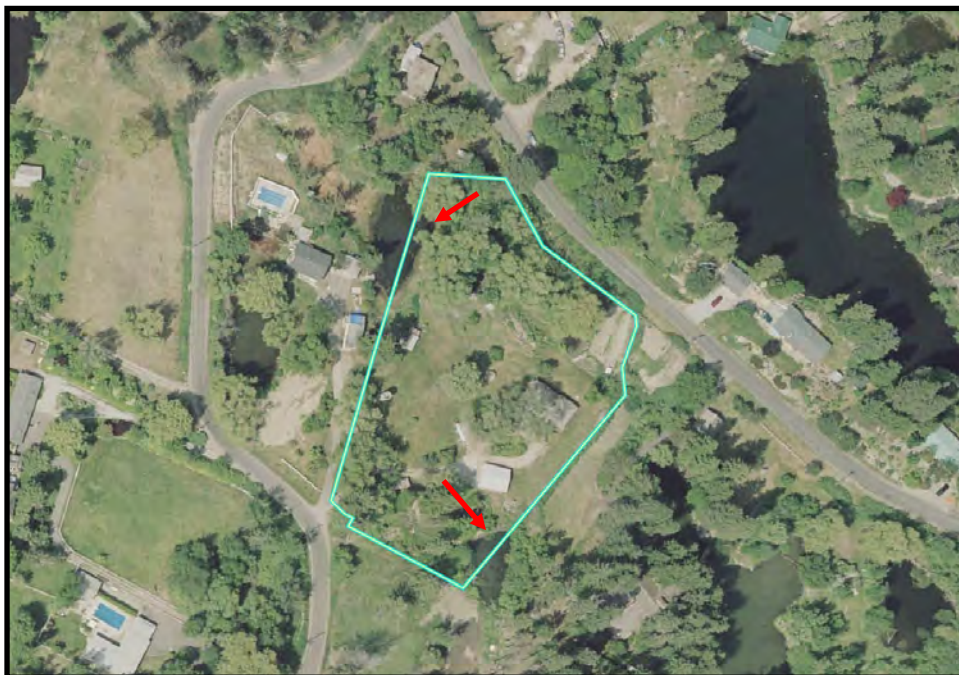
Photograph 2: Aerial photograph of the Site in the year 2003, a pond is shown to the northwest of the Site and to the southeast (Arrows indicate ponds).

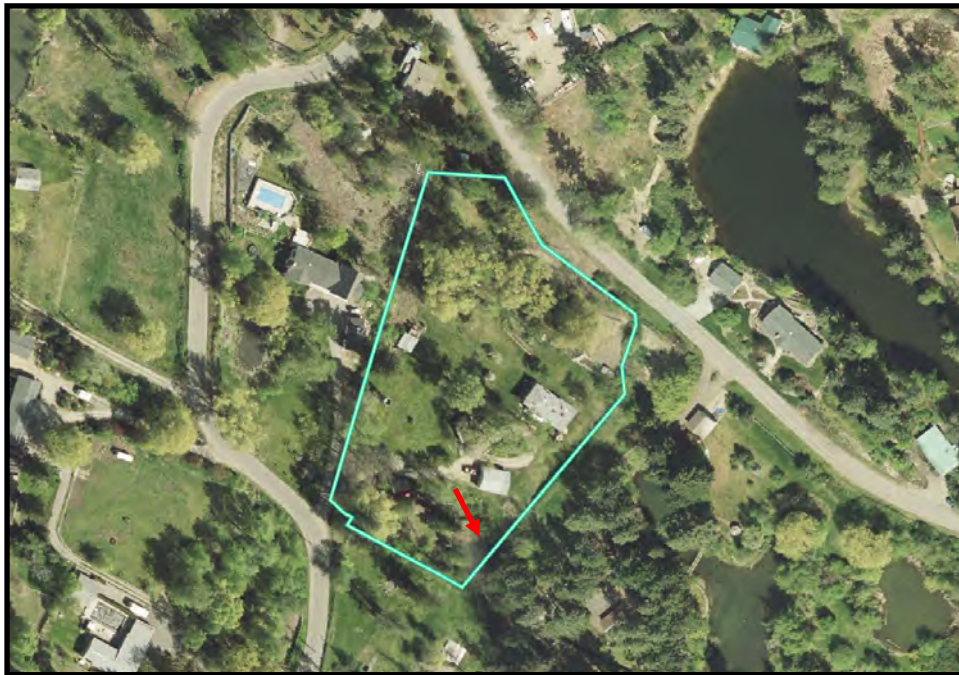
Photograph 3: Aerial photograph of the Site in the year 2006, the northwest pond is not observed and the southeast pond is shown (Arrow indicates the pond).

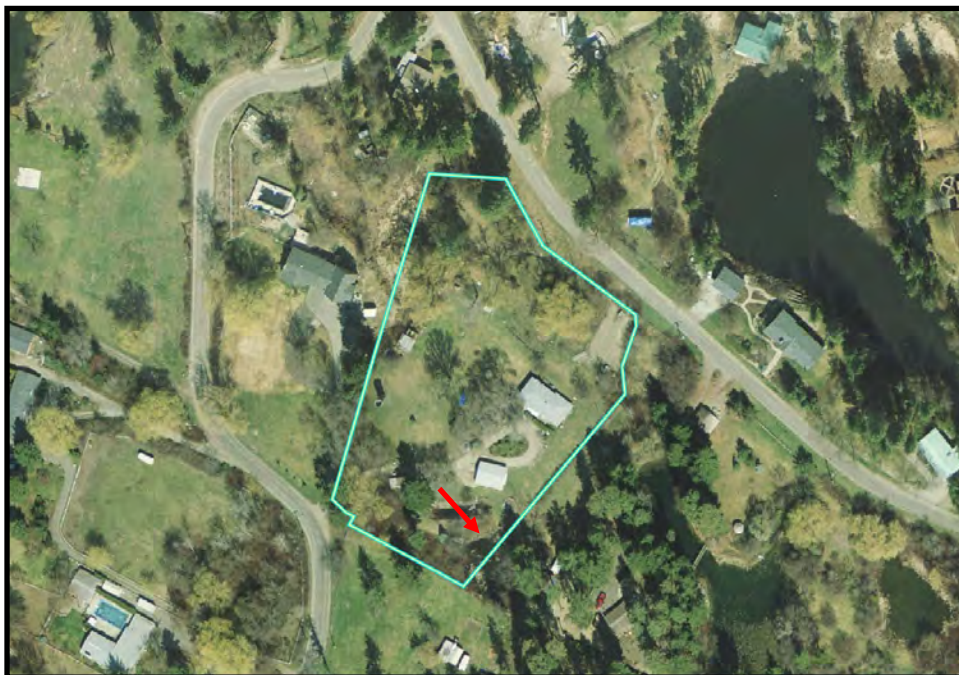
Photograph 4: Aerial photograph of the Site in the year 2009, the northwest pond is not observed and the southeast pond is shown (Arrow indicates the pond).

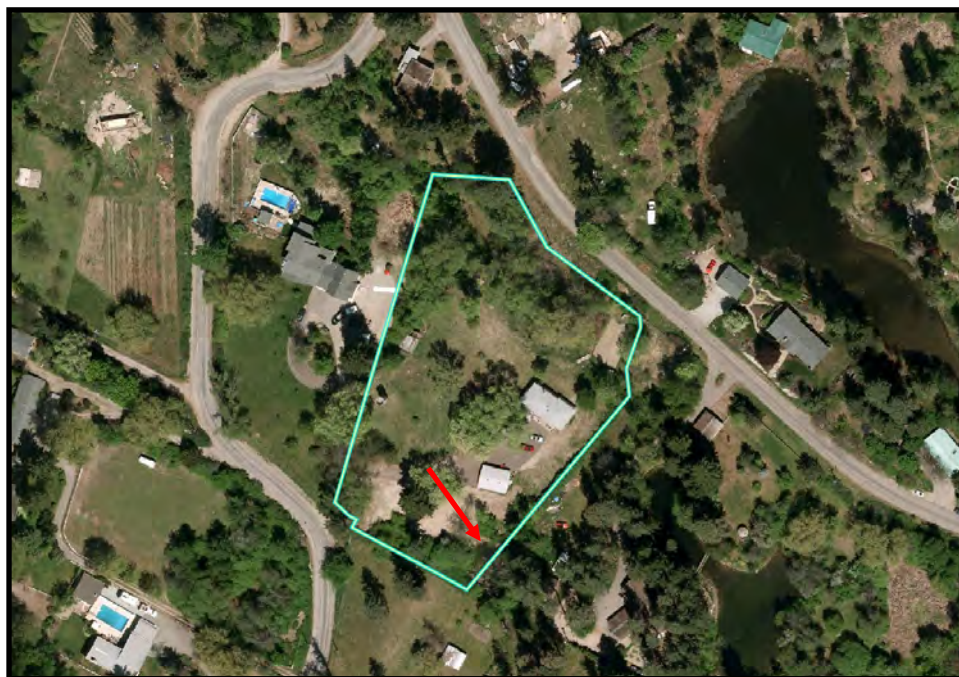
Photograph 5: Aerial photograph of the Site in the year 2012, the northwest pond is not observed and the southeast pond is shown (Arrow indicates the pond).

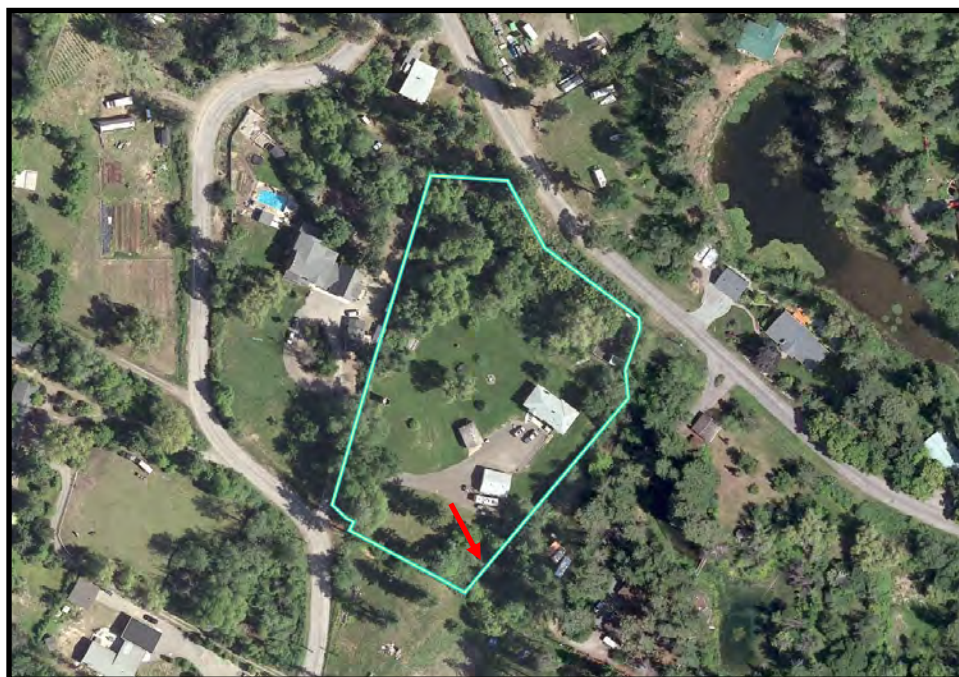
Photograph 6: Aerial photograph of the Site in the year 2015, the northwest pond is not observed and the southeast pond is shown (Arrow indicates the pond).

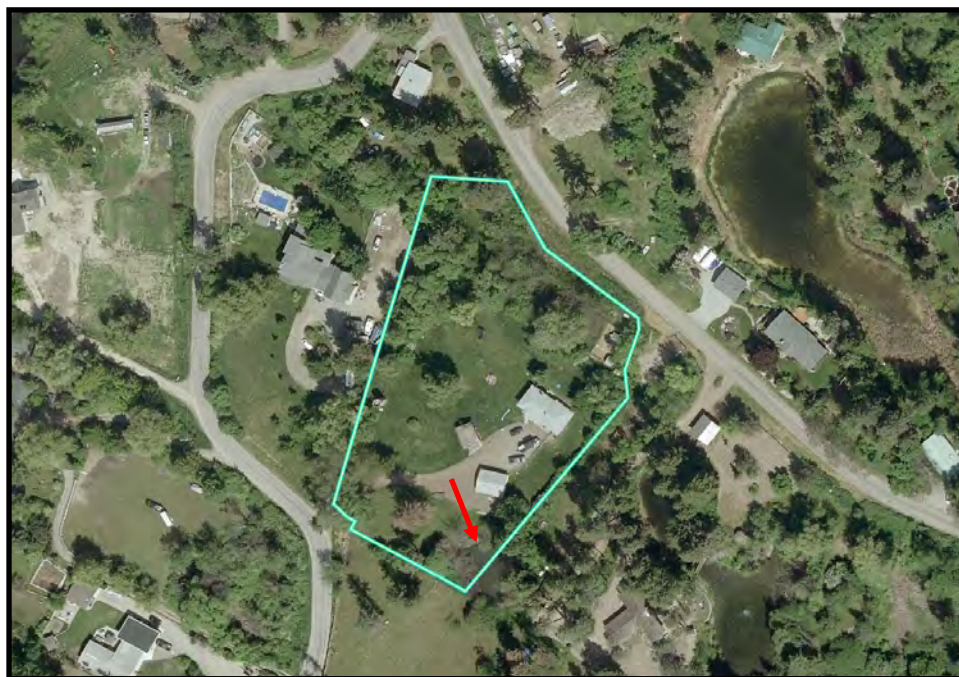
Photograph 7: Aerial photograph of the Site in the year 2017, the northwest pond is not observed and the southeast pond is shown (Arrow indicates the pond).

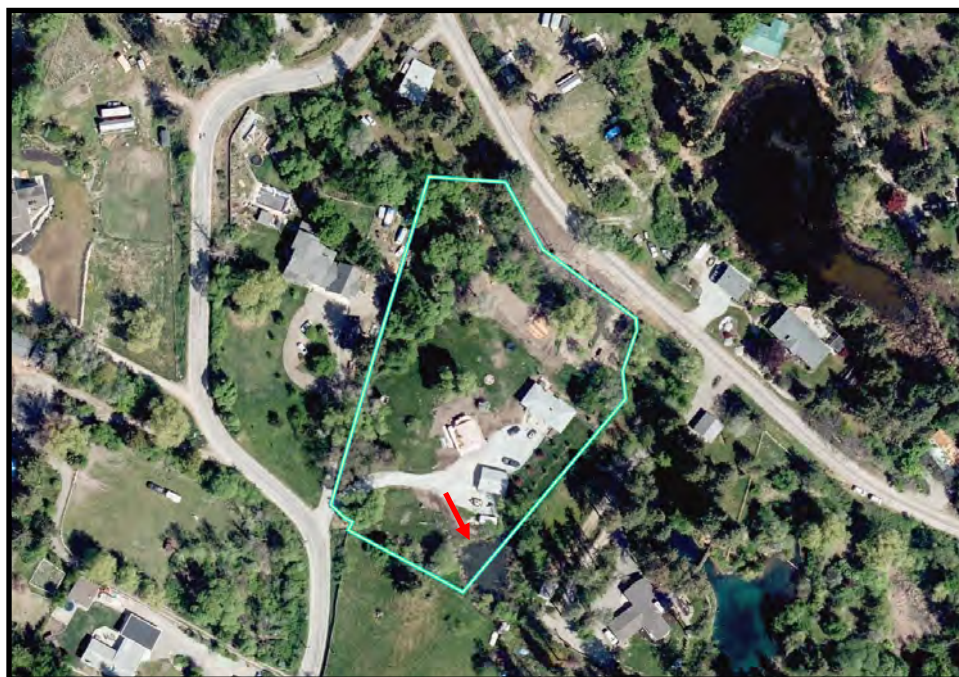
Photograph 8: Aerial photograph of the Site in the year 2019, the northwest pond is not observed and the southeast pond is shown (Arrow indicates the pond).

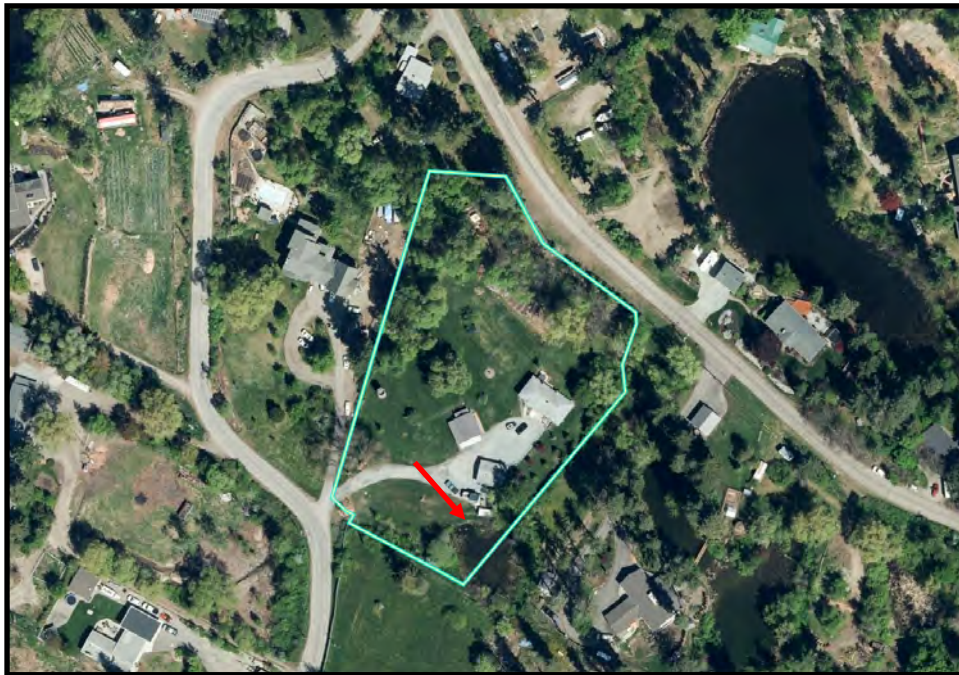
Photograph 9: Aerial photograph of the Site in the year 2021, the northwest pond is not observed and the southeast pond is shown (Arrow indicates the pond).
