## **KELOWNA IPD: REDEVELOPMENT OF PARKINSON RECREATION CENTRE (Phase 1)**

### **Arborist Report**

**Site Address:**  
1700-1800 Parkinson Way,  
Kelowna, BC V1Y 4P9

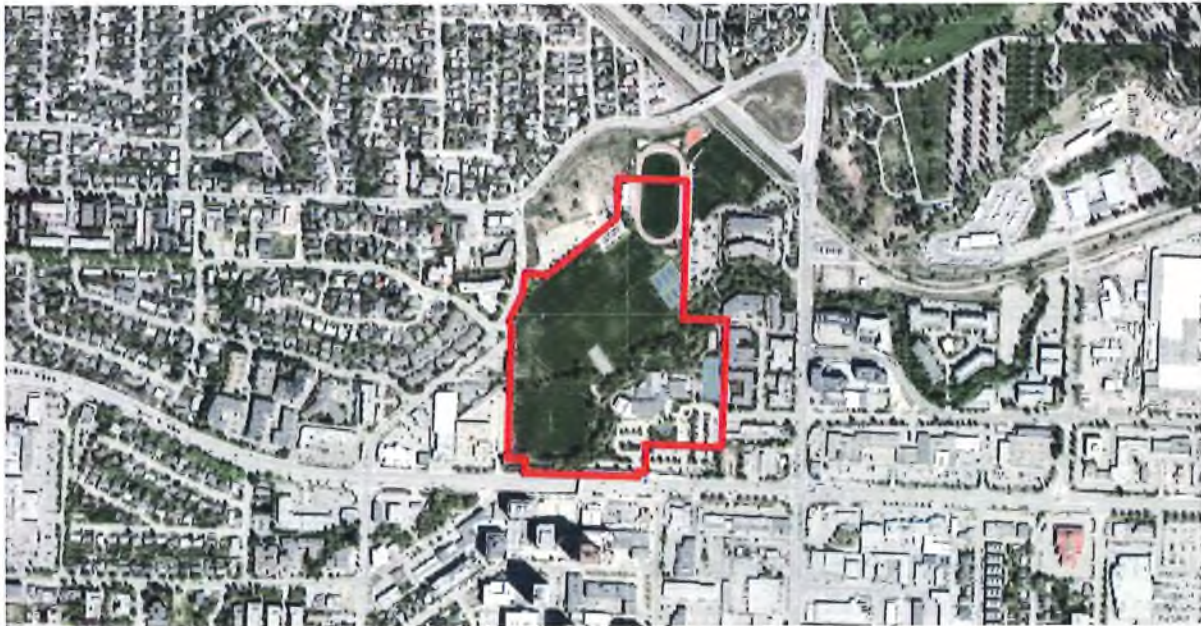
FIG. 1 - Site Outline (Kelowna, 2024)

The site is a recreation park located between Harvey and Clement Avenue, to the west of Spall Road. It is neighbored by single-family and multi-family lots, as well as commercial spaces and above ground parking. There is currently a recreation centre with concrete amenities, surface parking lots, and sports fields. Mill Creek flows southwest through a portion of the park.

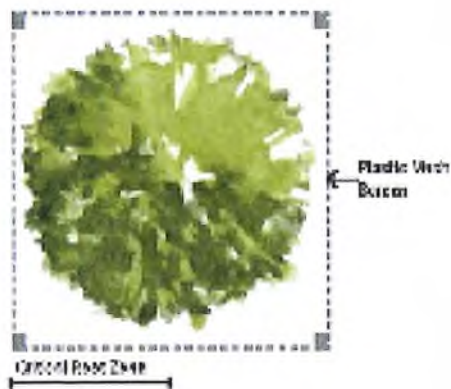
Elevation View

Specifications for Tree Protection Barriers

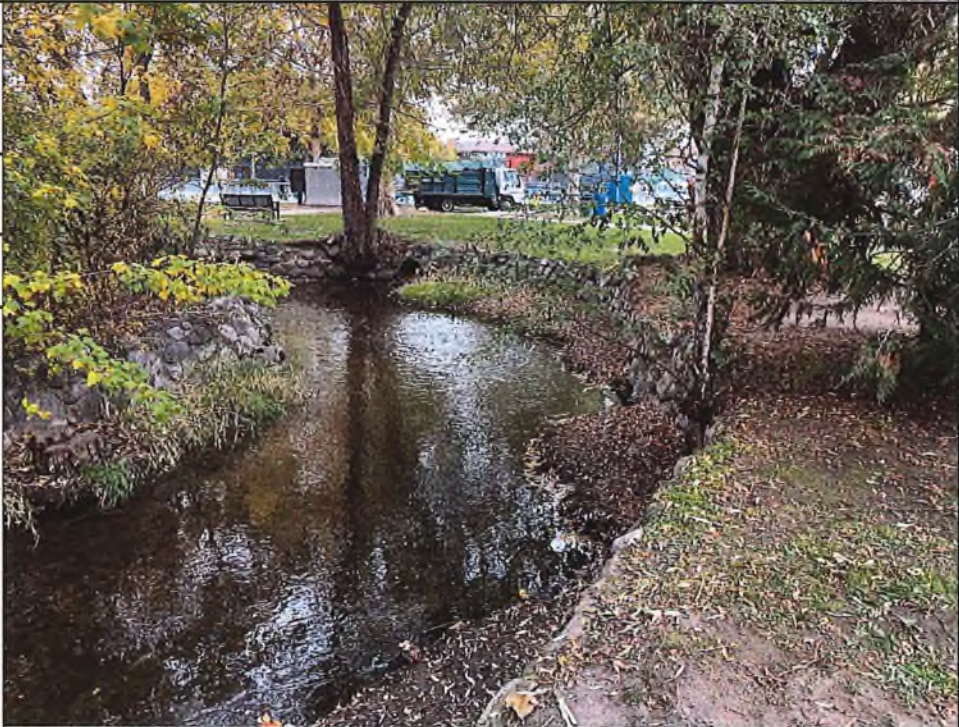
<b>Photo Location:</b> Sub-reach 3.2 49.883995°, -119.457594°			
<b>Direction:</b> Northeast			
<b>Survey Date:</b> 10/25/2024			
<b>Comments:</b> Upstream view showing the riparian area of Mill Creek approximately 480 m upstream of the Highway 97/Harvey Avenue crossing. The bend of the river is adjacent to the access to PRC from Highway 97. Douglas maple ( <i>Acer glabrum</i> ), weeping willows ( <i>Salix babylonica</i> ), and poplar ( <i>Populus nigra</i> ) can be seen.

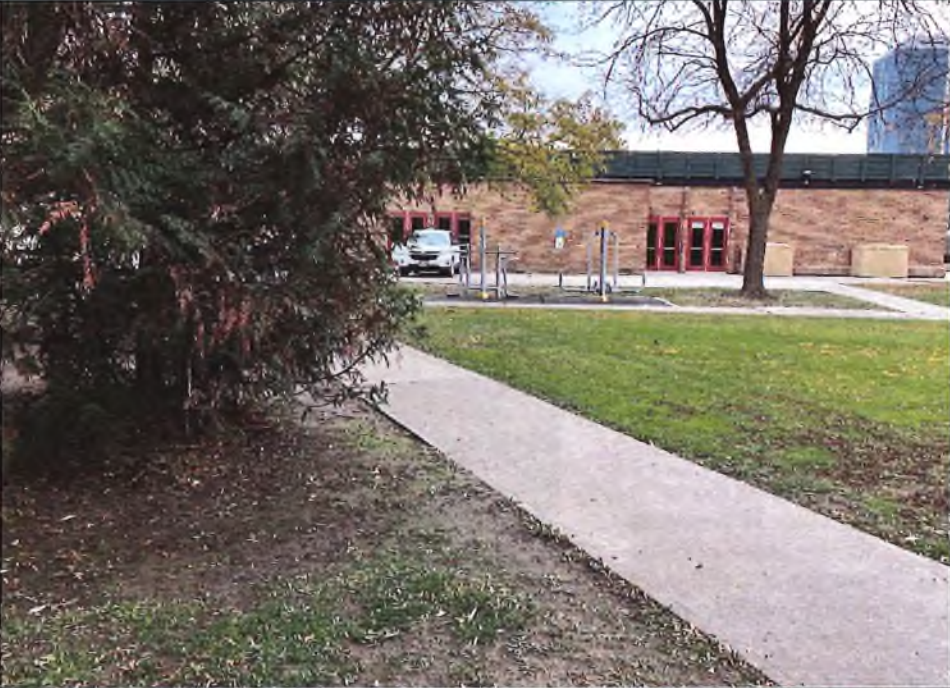
<b>Client:</b> City of Kelowna		<b>Project:</b> 111710161	
<b>Project:</b> Redevelopment of Parkinson Recreation Centre		<b>Site Location:</b> Parkinson Recreation Centre, Kelowna BC	
<b>Photograph ID:</b> 3

<b>Photo Location:</b> Sub reach 3.2 49.883778°, -119.457783°			
<b>Direction:</b> South			
<b>Survey Date:</b> 10/25/2024			
<b>Comments:</b> View of current PRC building looking south from Mill Creek by the outdoor fitness area. The paved walking path is within the RMA on the left bank of Mill Creek (creek is to the left of photo).			
<b>Photograph ID:</b> 4

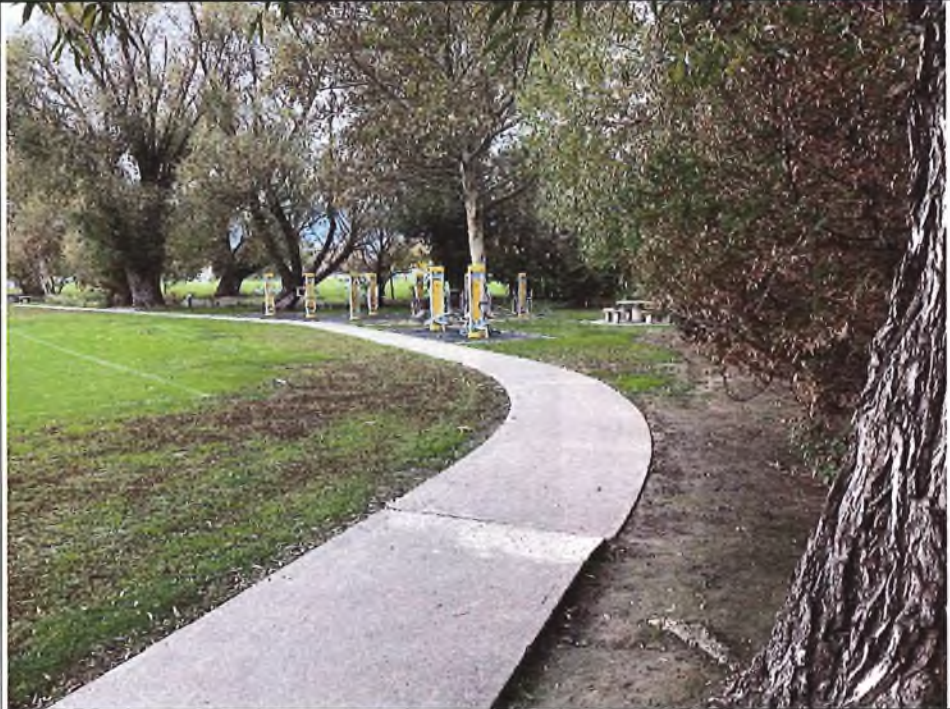
<b>Photo Location:</b> Sub reach 3.1 49.884024°, -119.458018°			
<b>Direction:</b> West			
<b>Survey Date:</b> 10/25/2024			
<b>Comments:</b> Mill Creek at the outdoor fitness area, north of the existing PRC building (left of photo). Mill Creek is to the right (north) of the outdoor fitness area; the fitness equipment and paved pathway are within the 15 m RMA.

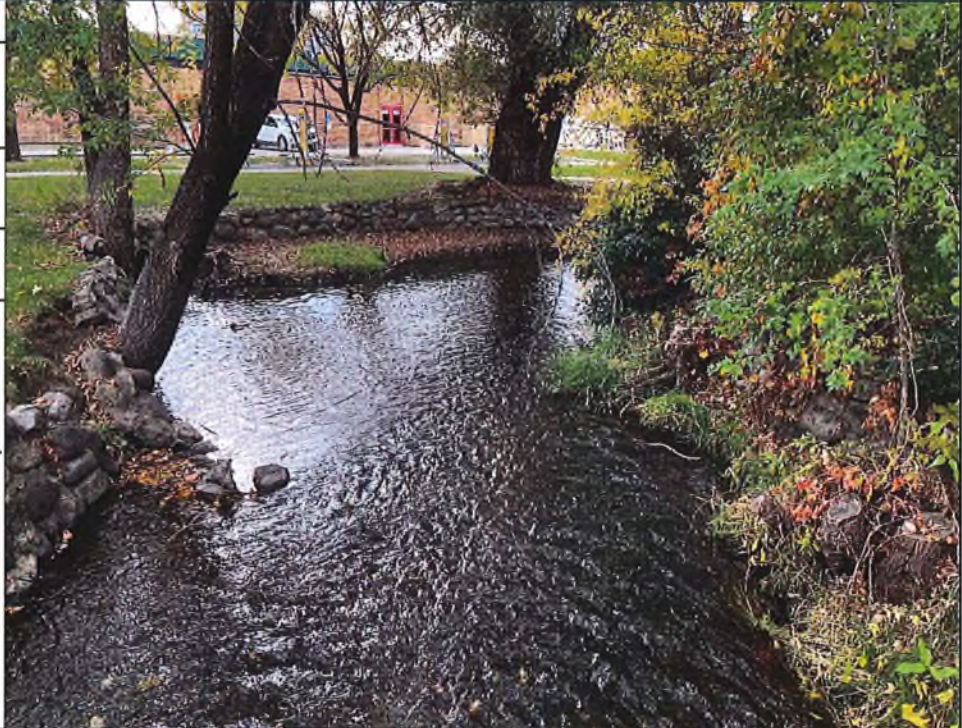
<b>Client:</b> City of Kelowna		<b>Project:</b> 111710161	
<b>Project:</b> Redevelopment of Parkinson Recreation Centre		<b>Site Location:</b> Parkinson Recreation Centre, Kelowna BC	
<b>Photograph ID:</b> 5

<b>Photo Location:</b> Sub-reach 3.2 49.883978°, -119.457477°			
<b>Direction:</b> Southwest			
<b>Survey Date:</b> 10/25/2024			
<b>Comments:</b> Downstream view of Mill Creek approximately 500 m upstream of the Highway 97/Harvey Avenue crossing. The photo was taken from the pedestrian bridge west of the pickleball courts. A grouted retaining wall forms the bank on river left. Introduced Siberian elm ( <i>Ulmus pumila</i> ) trees on the left and shrubs on the right.			
<b>Photograph ID:</b> 6

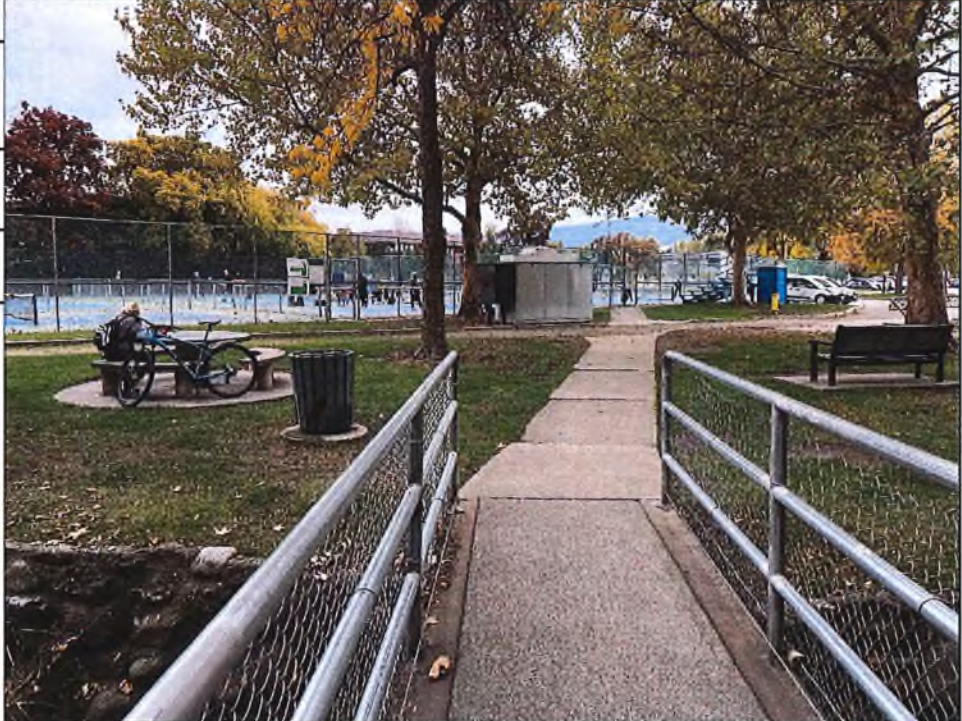
<b>Photo Location:</b> Sub-reach 3.2 49.883978°, -119.457477°			
<b>Direction:</b> Southeast			
<b>Survey Date:</b> 10/25/2024			
<b>Comments:</b> View of pedestrian bridge and pickleball courts to the left. Manicured lawn on north side of Mill Creek. Black locust ( <i>Robinia pseudoacacia</i> ) trees can be seen in the photo.

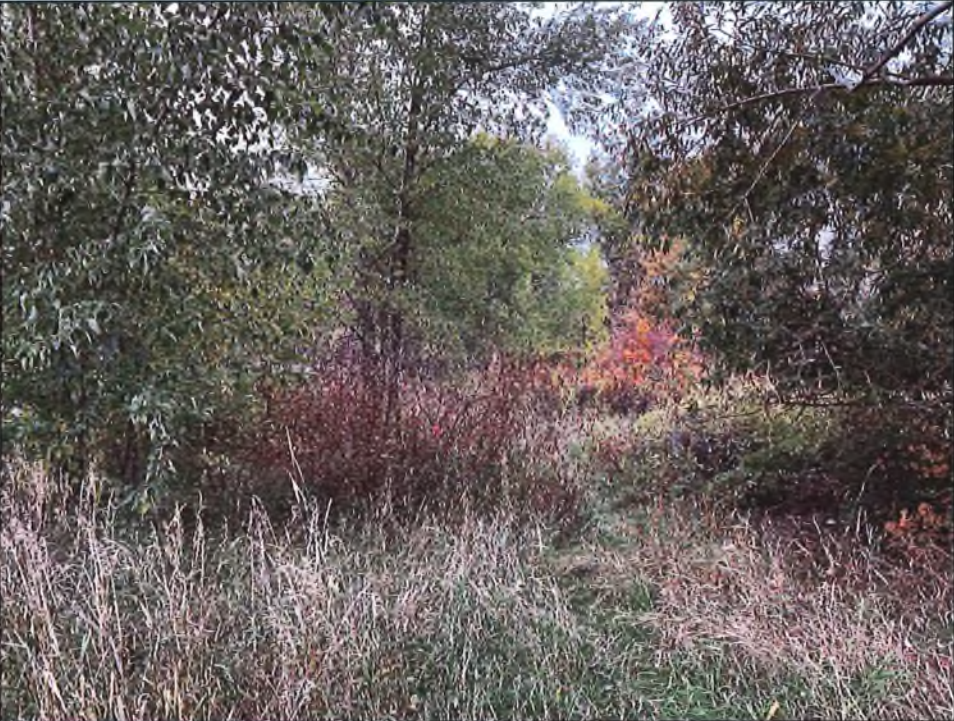
<b>Client:</b> City of Kelowna		<b>Project:</b> 111710161	
<b>Project:</b> Redevelopment of Parkinson Recreation Centre		<b>Site Location:</b> Parkinson Recreation Centre, Kelowna BC	
<b>Photograph ID:</b> 7

<b>Photo Location:</b> Sub-reach 3.2 49.884742, -119.457494			
<b>Direction:</b> North			
<b>Survey Date:</b> 10/25/2024			
<b>Comments:</b> A 426 m <sup>2</sup> occurrence of black cottonwood/common snowberry – roses ecosystem ( <i>Populus trichocarpa</i> / <i>Symphoricarpos albus</i> - <i>Rosa</i> spp.) a red listed ecological community was identified between the tennis courts and Mill Creek.			
<b>Photograph ID:</b> 8

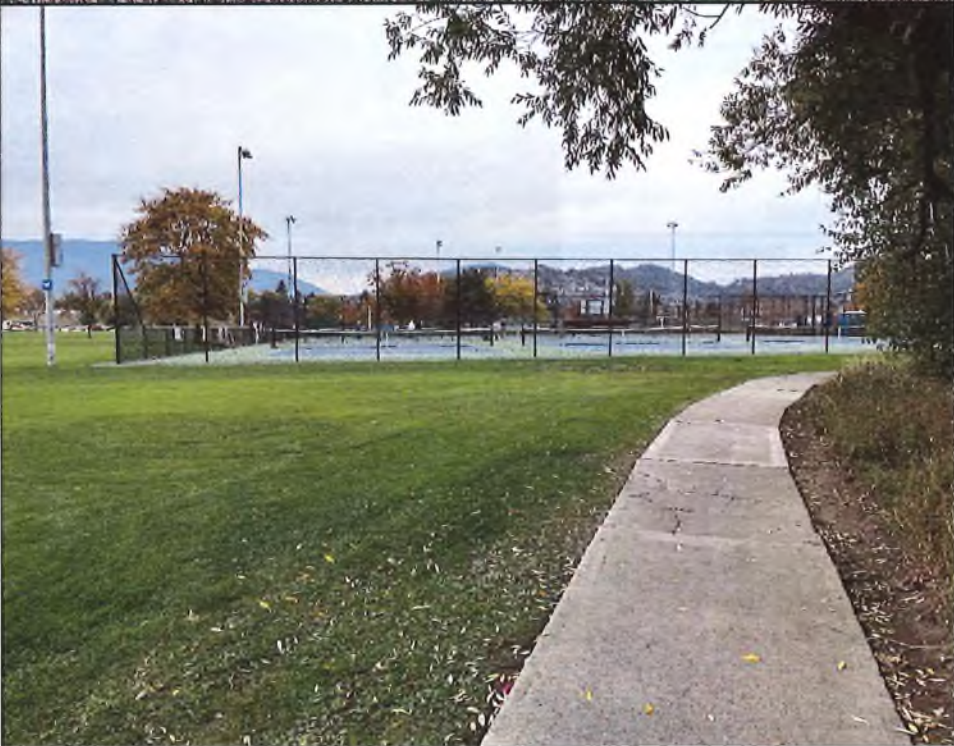
<b>Photo Location:</b> Sub-reach 3.2 49.884476°, -119.457682°			
<b>Direction:</b> North			
<b>Survey Date:</b> 10/25/2024			
<b>Comments:</b> View of paved walking trail, manicured lawn, and tennis courts looking north. Mill Creek is to the right of photo. This area overlaps with the proposed footprint for the new PRC building. The red-listed community is located to the right (east) of this photo.

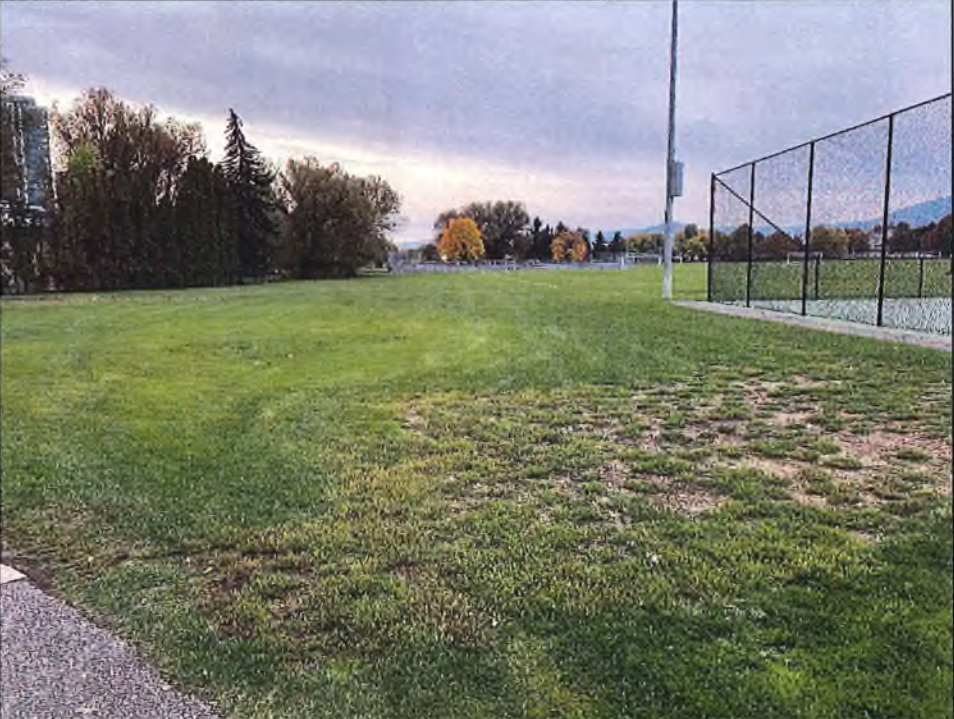
<b>Client:</b> City of Kelowna		<b>Project:</b> 111710161	
<b>Project:</b> Redevelopment of Parkinson Recreation Centre		<b>Site Location:</b> Parkinson Recreation Centre, Kelowna BC	
<b>Photograph ID:</b> 9

<b>Photo Location:</b> Sub-reach 3.2 49.884673°, -119.457728°			
<b>Direction:</b> West			
<b>Survey Date:</b> 10/25/2024			
<b>Comments:</b> Manicured lawn area and weeds within the proposed footprint for the new PRC building. Mill Creek is to the left of photo (south); the southwest corner of the tennis courts can be seen on the right of the photo.			
<b>Photograph ID:</b> 10

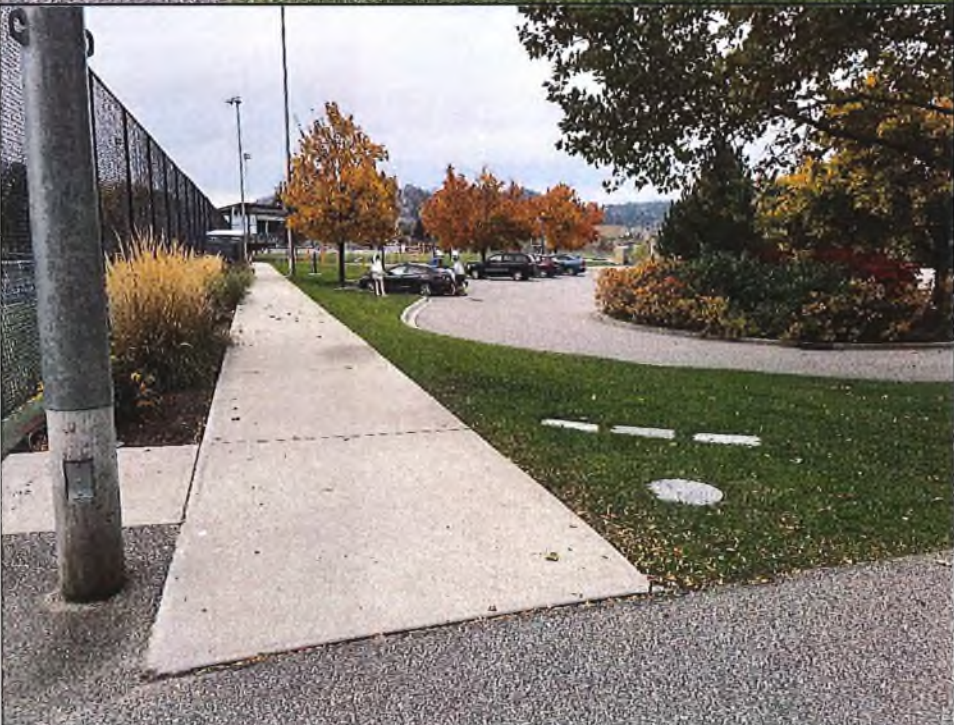
<b>Photo Location:</b> Sub-reach 3.2 49.884928°, -119.457453°			
<b>Direction:</b> North			
<b>Survey Date:</b> 10/25/2024			
<b>Comments:</b> Looking north from walking path along the north (right) bank of Mill Creek. Proposed footprint for the new PRC building overlaps with tennis courts to left (west), sidewalks, walking path, manicured lawns, and parking lot. Mill Creek is behind (south) of where photo is taken from.

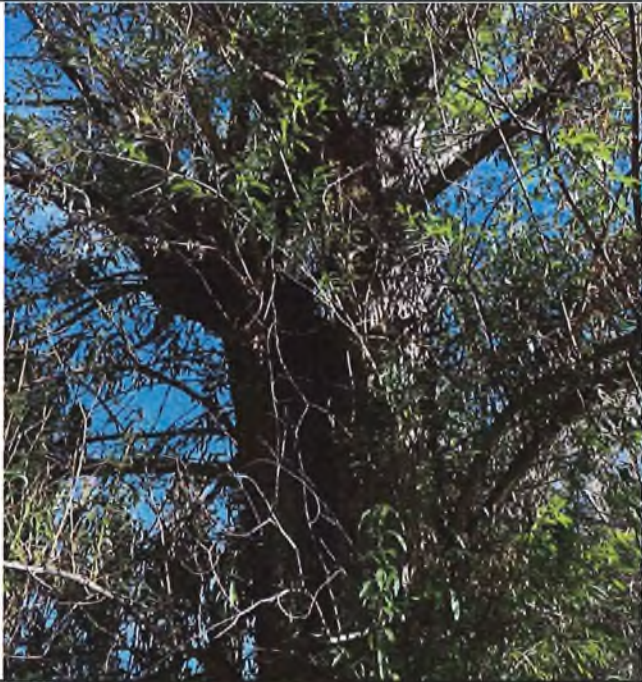
<p><b>Client:</b> City of Kelowna</p> <p><b>Project:</b> 111710161</p>	
<p><b>Project:</b> Redevelopment of Parkinson Recreation Centre</p> <p><b>Site Location:</b> Parkinson Recreation Centre, Kelowna BC</p>	
<p><b>Photograph ID:</b> 11</p>

<p><b>Photo Location:</b> Sub-reach 3.1 49.884144°, -119.458301°</p>	
<p><b>Direction:</b> N/A</p>	
<p><b>Survey Date:</b> 10/10/2024</p>	
<p><b>Comments:</b> Nesting cavity was observed in a willow tree within the riparian area of Mill Creek. This tree is located approximately 400 m upstream of the crossing with Highway 97/Harvey Avenue on the north side of Mill Creek.</p>	
<p><b>Photograph ID:</b> 12</p>	<div style="text-align: center;"> <p><b>North Elevation</b></p> <p>◉ 160°S (T) LAT: 49.882448 LON: -119.460119 ±4m ▲ 356m</p>

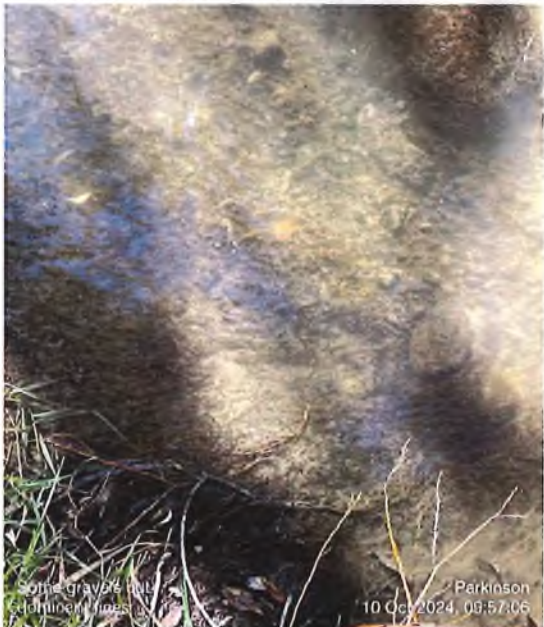
<p style="font-size: small;">Some gravels still dominant in places</p> <p style="text-align: right; font-size: small;">Parkinson 10 Oct 2024, 06:57:05</p> </div>
