CITY OF KELOWNA

MEMORANDUM

Date: April 15, 2008
File No.: 0710-20
To: City Manager
From: Civic Properties Project Supervisor
Subject: Laurel Packinghouse Structural

Structural Review
of the
Laurel Packinghouse Building
(The Wine Museum)
130-4 Ellis Street, Kelowna

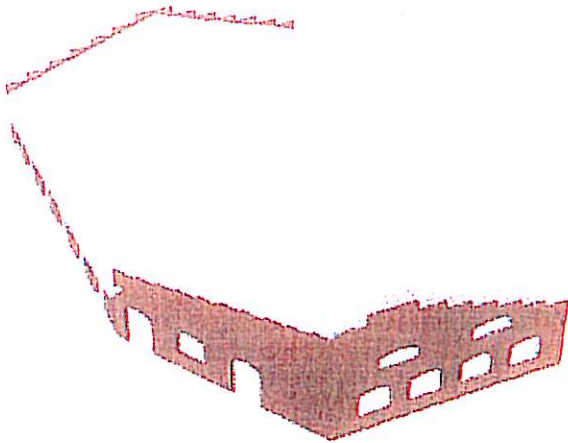
Figure 4 -- Original Structure

The upshot of this discussion is that there presently exists no well-defined path by which lateral loads in either orthogonal direction might be transmitted into the foundation. The discontinuous nature of the load path for lateral loads might best be illustrated by reference to Figures 4, 5 and 6, being three-dimensional renderings of the building in the 'before' state (Figure 4), 'after' the 1983 renovation (Figure 5), and after the 1983 renovation, with the roof removed to provide a clear view of how the second floor diaphragms are not connected to the perimeter shearwalls. It must be noted that the existing heavy-timber trusses do nothing as regards resistance to lateral loads; for lateral loads in the north-south direction, these trusses merely transfer lateral loads from the second floor diaphragm into the heavily-perforated roof diaphragm. Similarly, the shed roofs over the new (1983) second floor offices cannot be counted on to contribute anything to the stiffness of the roof diaphragm because of the continuous strip of windows. The glazing would have to act as part of the diaphragm for the shed roofs to be effective, and this is clearly not allowed.

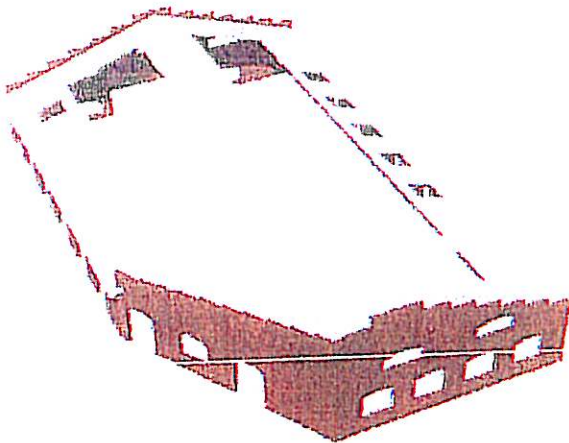
Figure 5 -- Roof after 1983 renovation

Implementation of the 1983 Woodworth design involved removal of a substantial portion of the original roof surface and replacement of that surface by a new continuous shed dormer on either side of the ridge. This work effectively eliminated the diaphragm function of the original roof surface over the extent where that original roof was removed. Outside the bounds of the new shed roof, two rows of skylights were added, one in each bay between adjacent trusses. These skylights limit the effectiveness of the remaining portion of the original diaphragm. Furthermore, the new shed roof surfaces cannot be said to act as an effective roof diaphragm, because they do not connect with any wall element that might act as a shearwall. That is, the 'outside' wall at the extremity of each shed roof is perforated by a continuous strip of fenestration, and no wall exists beneath the intersection of the 1983 shed roof surface and the original roof surface.

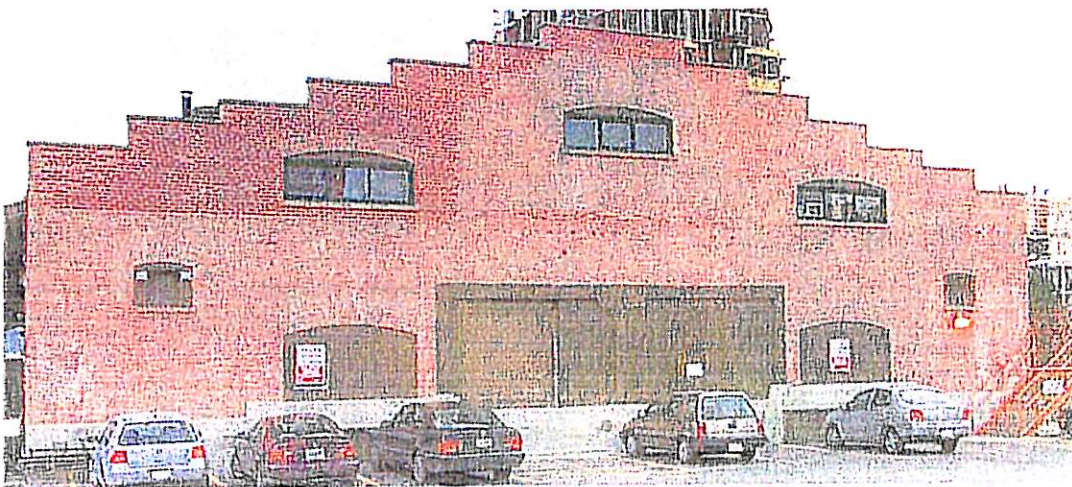
The bricks of the external masonry walls are constructed of local red bricks, possibly from Kelowna Brick Works. During the 1983 rehabilitation, the walls were partially rebuilt, but the original bricks or similar salvaged bricks were used on the rebuilt areas; the outline of the change in brick is visible in some areas.

Fig 8: West elevation with different brick types indicating sections rebuilt with old (right) and modern (left) bricks during the 1983 rehabilitation

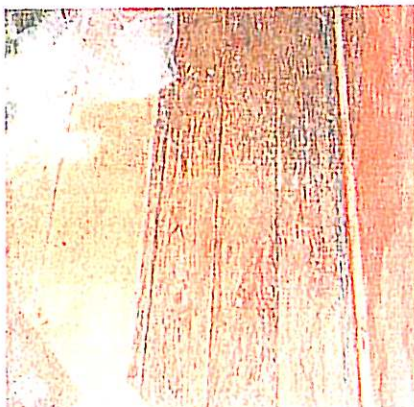
The original floorboards on the Main Level are still present, covered by the current floor covering.

Fig 17: Original floorboards (right) under newer floor covering (left) Main Level

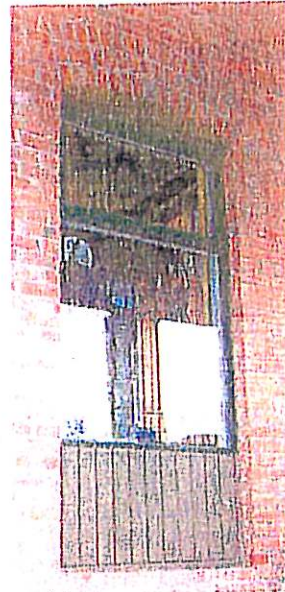
Fig 21: Replacement window

The Upper Level gable windows are replacements. The fenestration was altered to accommodate the new use on the north and south elevations – windows changed to doors, opening sizes changed or blocked. Archival photographs are a useful aide in determining the original window style and fenestration.

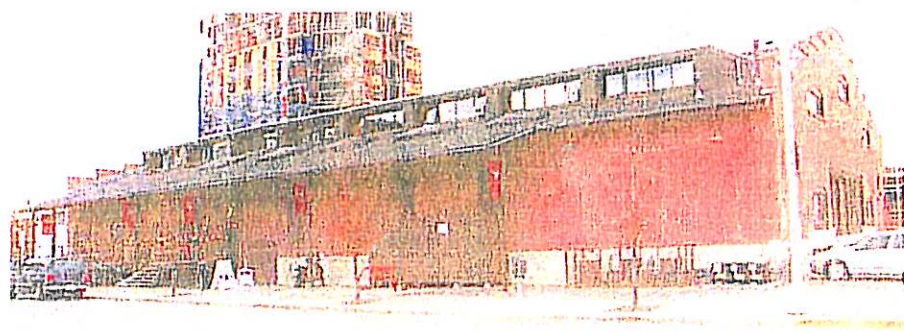
Fig 23: Current fenestration on north elevation. Note openings blocked at west end

- Monitor cracks in brick and concrete and continue to investigate
- Removing the cementitious mortar at this stage would be more damaging to the brick. However, if decay (efflorescence, spalling) continues or carrying out repairs, use weaker, lime-based mortar.
- Restore window and door styles, based on archival images. Preserve existing original windows.
- Remove existing attachments on north and south elevation. Keep south-east ramp and promenade (if code compliant). Reinstall original loading docks, with necessary modification to comply with code. These modifications should be contemporary, simple and visually unobtrusive.
- Restore original roof profile by removing shed dormers. Later skylights can be retained for internal illumination.
- Introduce an historically-appropriate roof ridge sign similar to the one on this nearby building in the 1928 photograph.

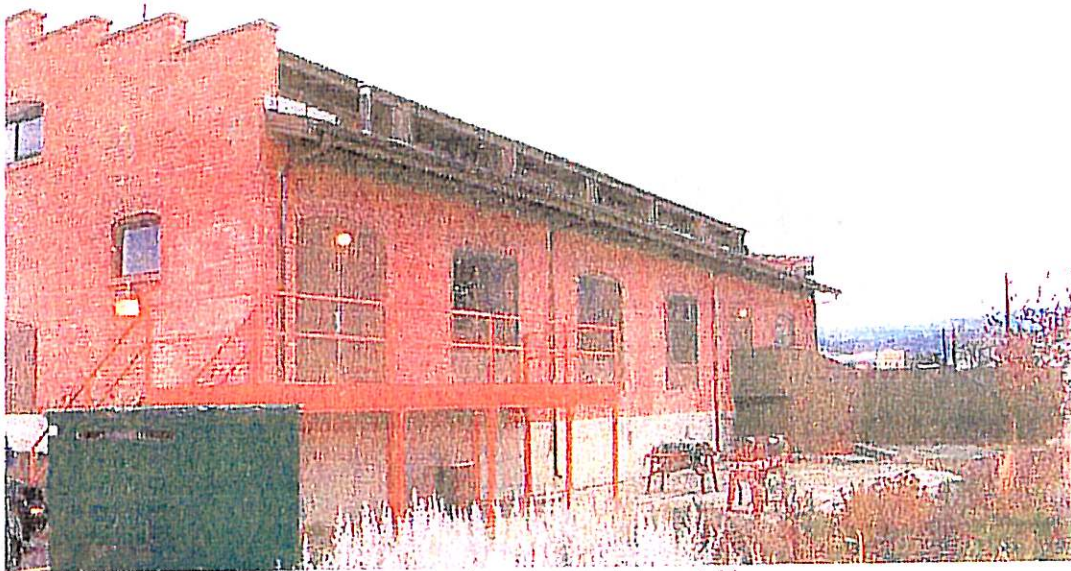
There are currently different types of wood ramps and steps attached to the building on the north, south and south east elevations. This is because the main floor is higher than street level. They date from the 1983 rehabilitation, except for the dock area on the south east elevation designed in 1987. Their condition is good, but they give the building a piecemeal appearance.

Fig 25: Different dock types on the south façade with original cleats visible
