TERRENO "A Hillside Development"

Lot 1, Plan 84653, 2755 McCurdy Road, Kelowna, BC

Environmental Impact Assessment

May 2022 File No. 19-2765

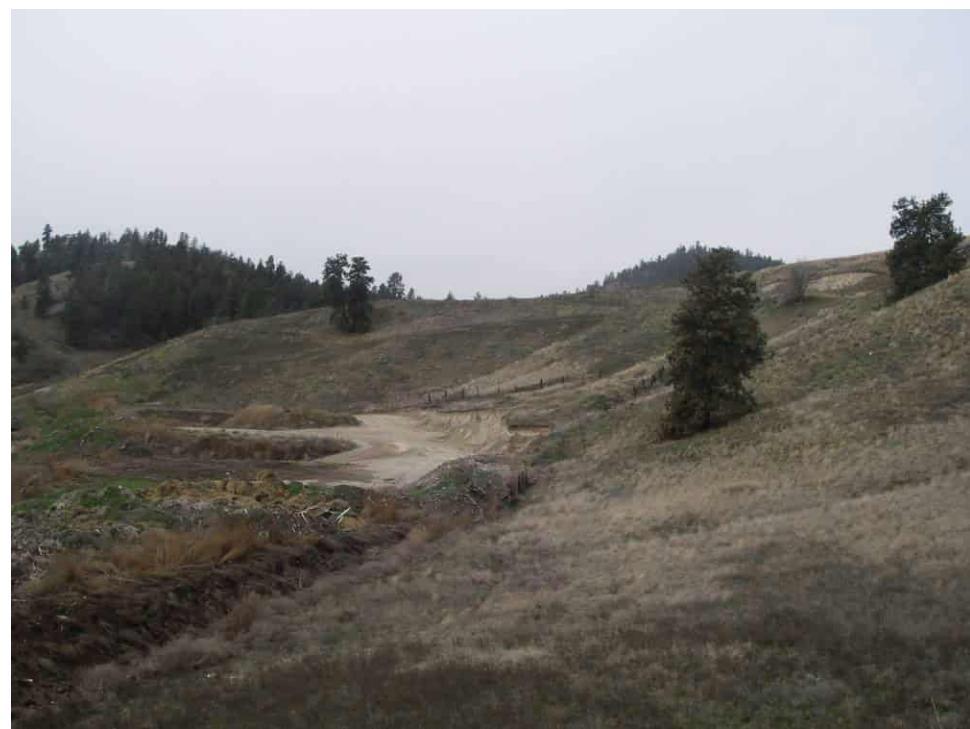
Photo 1. Shows a grassland portion (Rough Fescue – Bluebunch wheatgrass) of the subject property that tends to be invested with invasive species (Photo taken April 4, 2008).

The SEI identified three distinct grassland communities within the subject property: 1) Rough fescue – Bluebunch wheatgrass (FB-PPxh1-00) tends to be the most disturbed and is found along the northern and southern boundaries of the property (**Photo 1**); Bluebunch wheatgrass – Balsamroot (WB-PPxh1-93) is much more intact, with little weed coverage in most areas (**Photo 5**). This community tends to occur on steeper slopes where there has been less disturbance, and; 3) Selaginella - Bluebunch wheatgrass - Rock outcrop (SB-IDFxh1-00) only sparsely occurs, representing approximately 2% of the subject property (**Photo 6**).

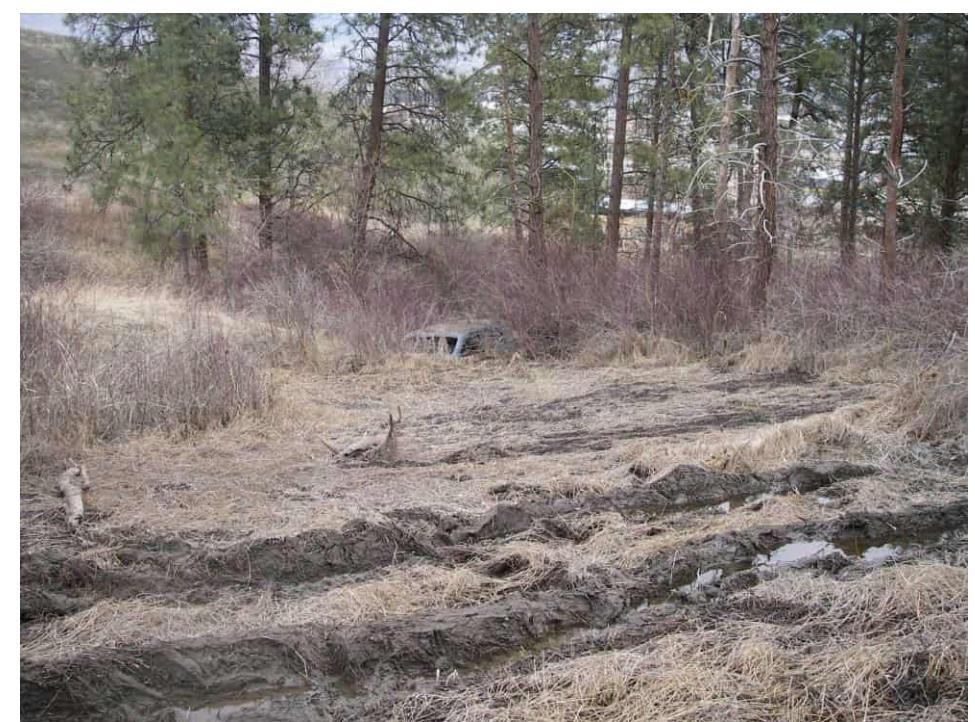
Photo 2. Depicts 4x4 activity in the riparian corridor of the tributary to Mill Creek (Photo taken April 4, 2008).

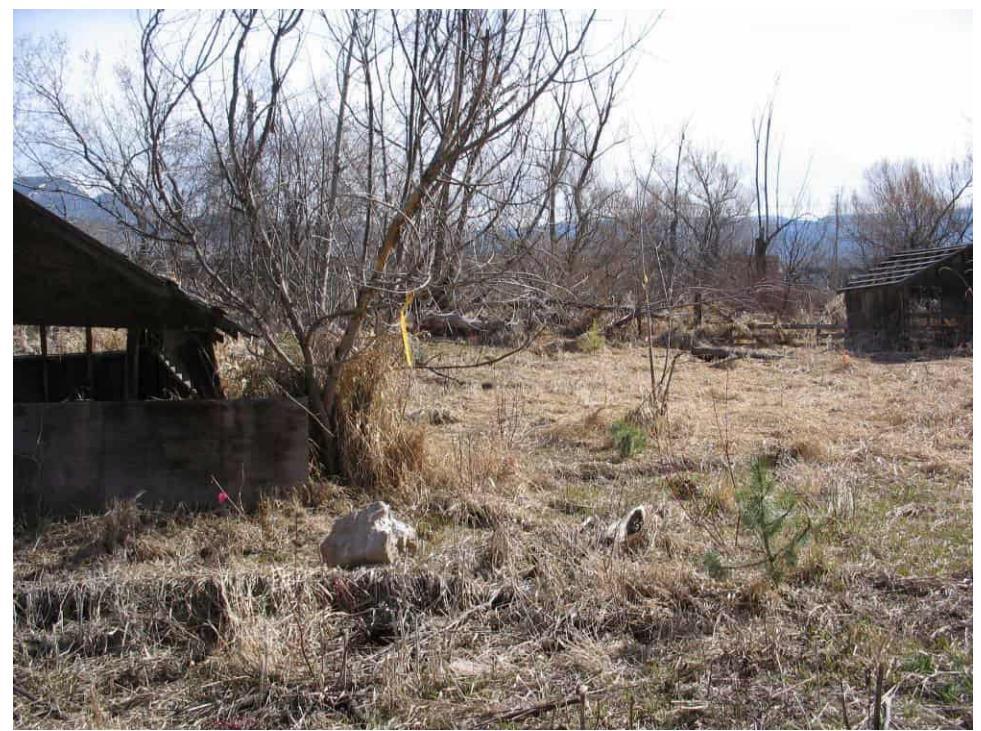
Photo 3. Shows old, dilapidated structures that occur immediately adjacent to Mill Creek.

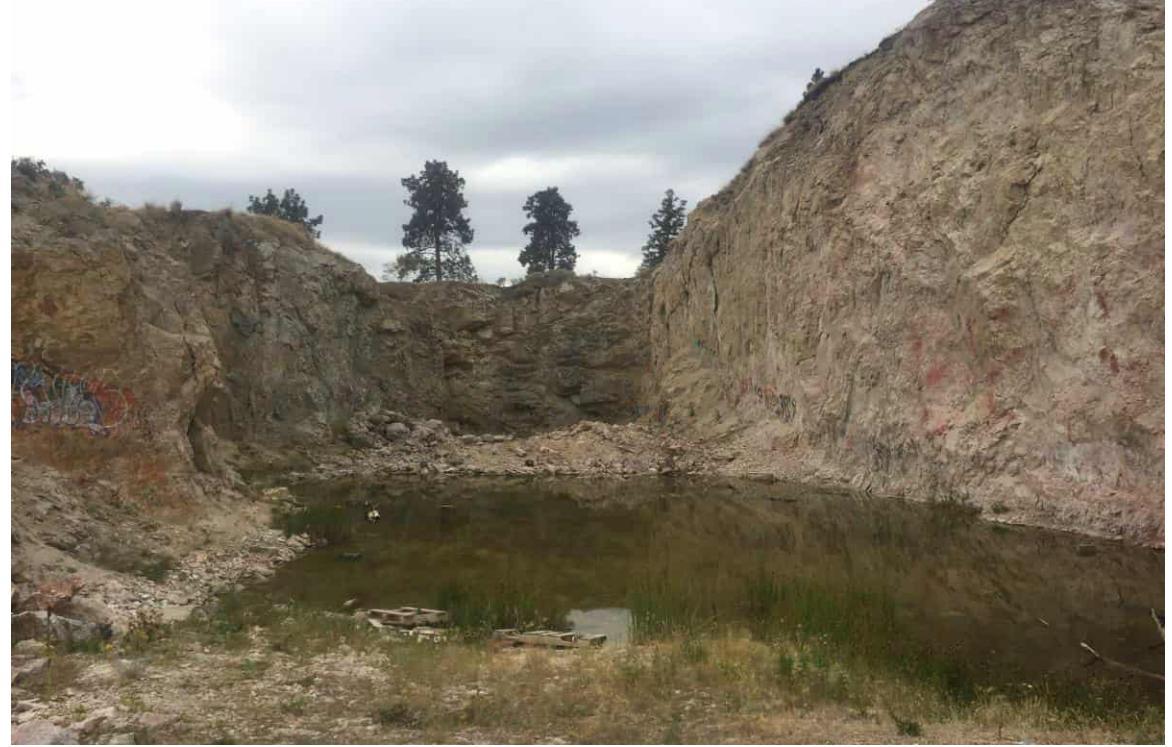
Photo 4. Shows some of the impacts from blasting activity for the Central Okanagan Multimodal corridor (Photo taken Sept 12, 2021).

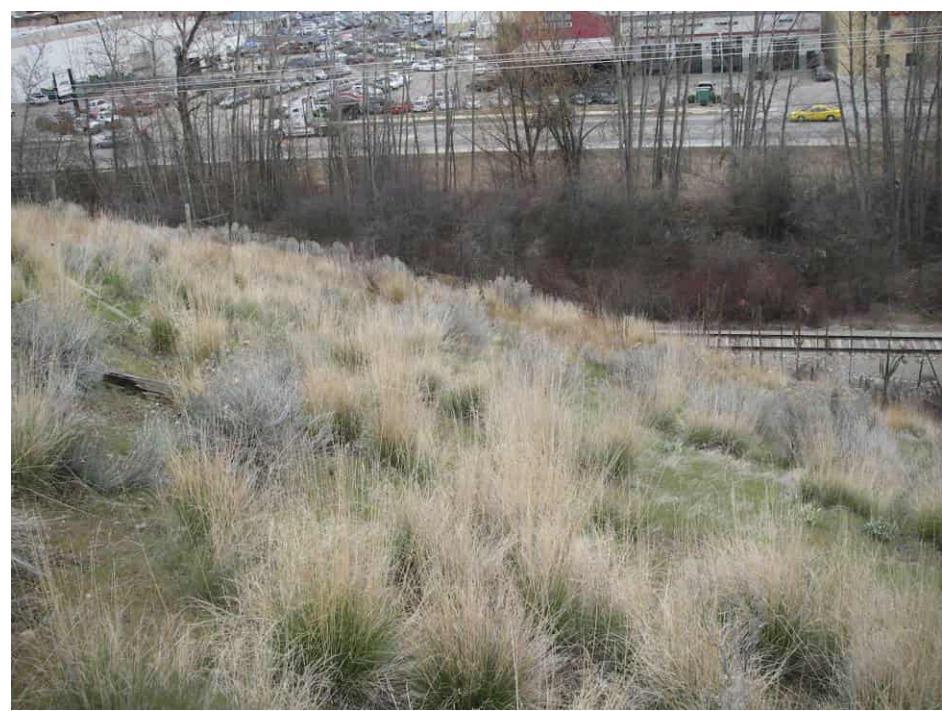
Photo 5. Shows the Bluebunch Wheatgrass – Balsamroot ecosystem community (WB) that occurs throughout the subject property (Photo taken April 4, 2008).

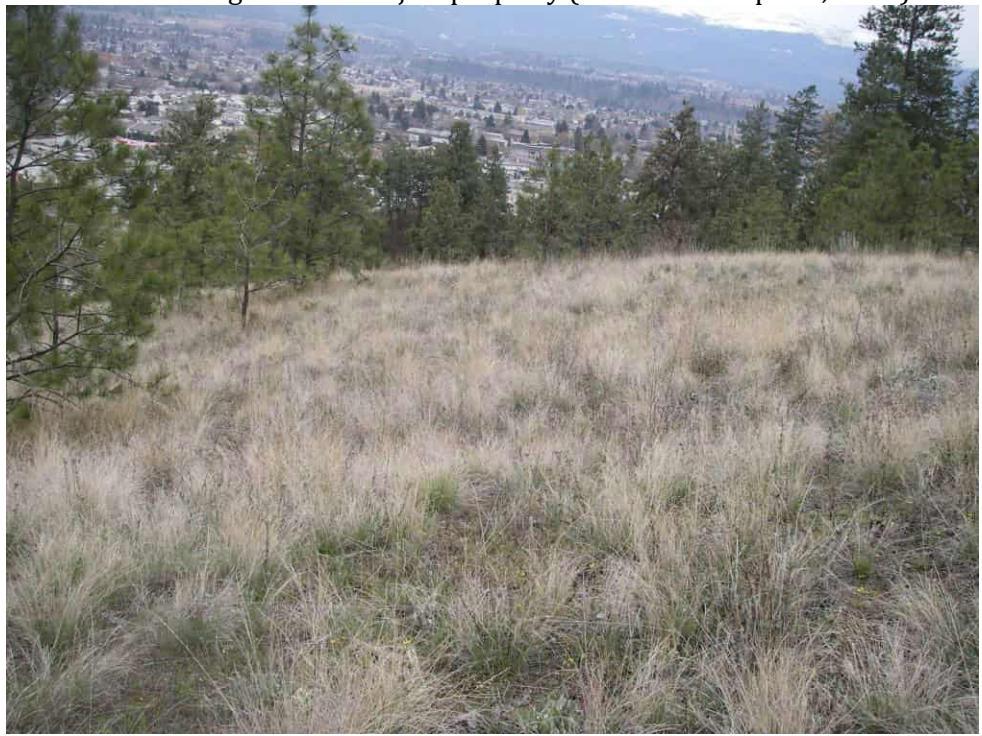
Photo 6. Depicts the Selaginella – Bluebunch Wheatgrass rock outcrop (SB) association (Photo taken April 4, 2008).

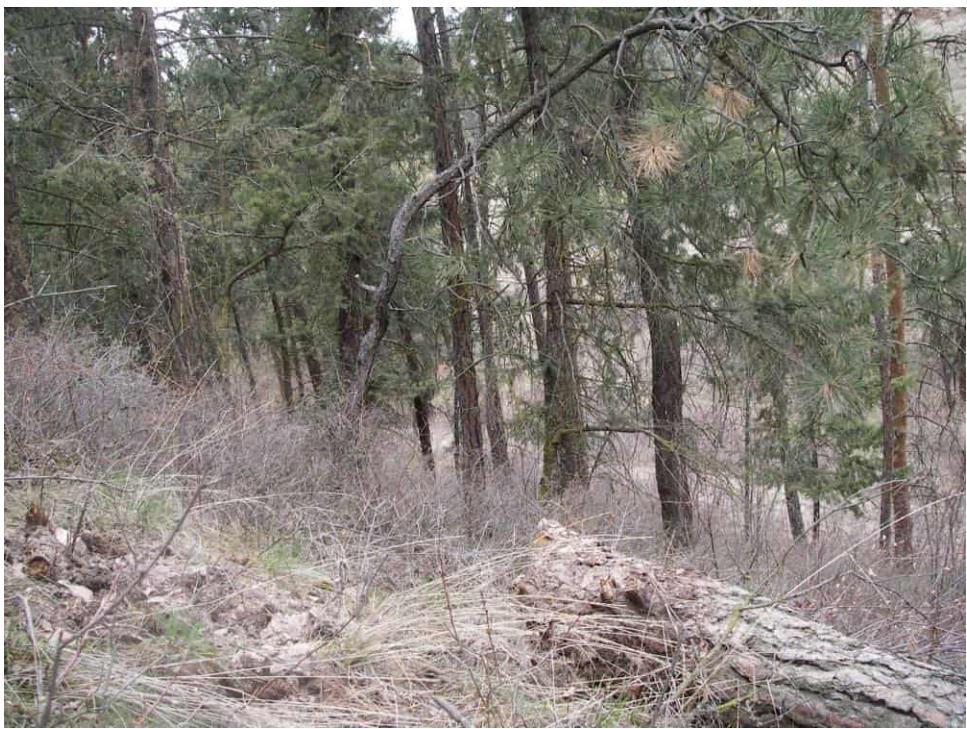
Photo 7. Shows the Rough fescue – Bluebunch Wheatgrass community that occurs within the subject property (Photo taken April 4, 2008).

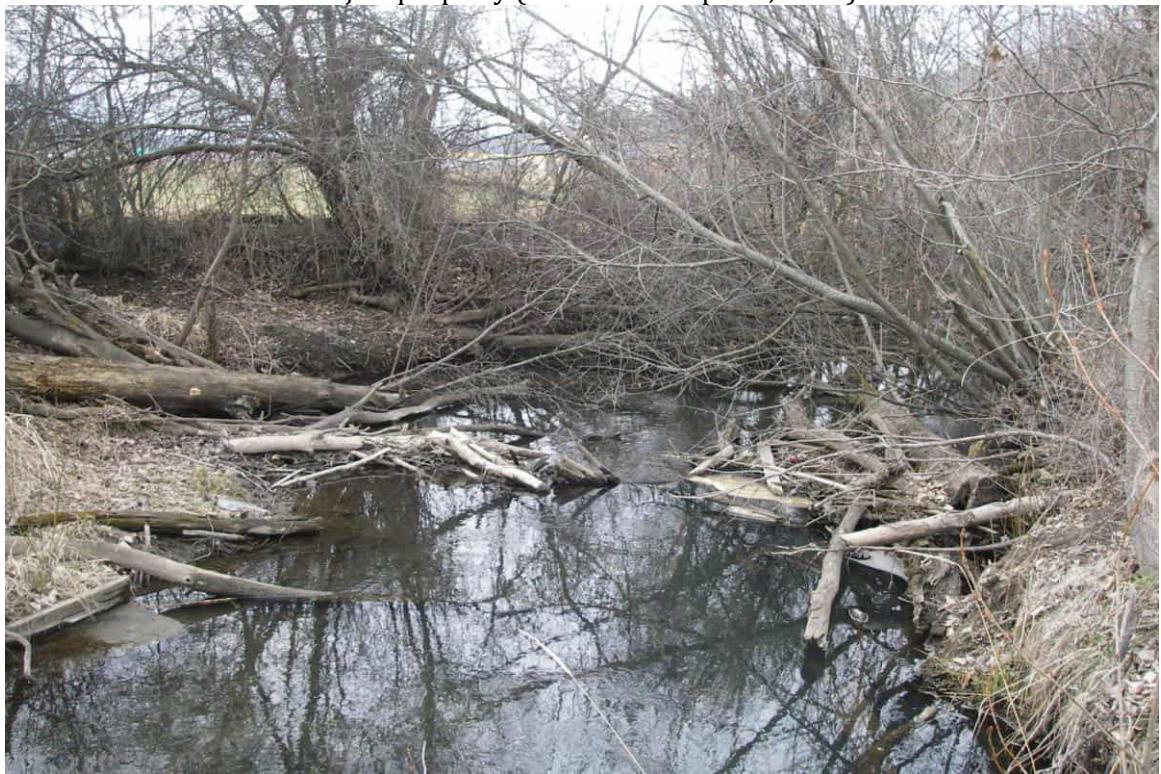
Photo 8. The above photo depicts the Black cottonwood/Douglas-fir – Common Snowberry-Red-osier Dogwood Riparian fringe community (CD-IDFxh1- 00) that lines Mill Creek (Photo taken April 4, 2008).

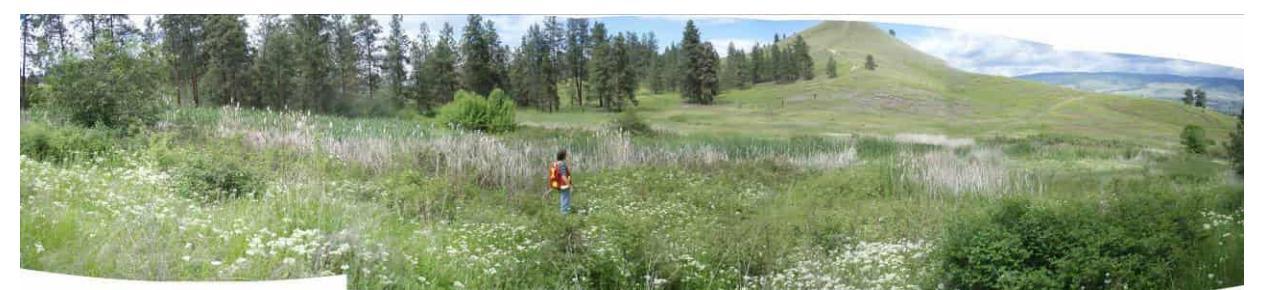
Photo 9. The above photo depicts the cattail marsh that is associated with the ancillary riparian corridor to Mill Creek (Photo taken on June 11, 2008).

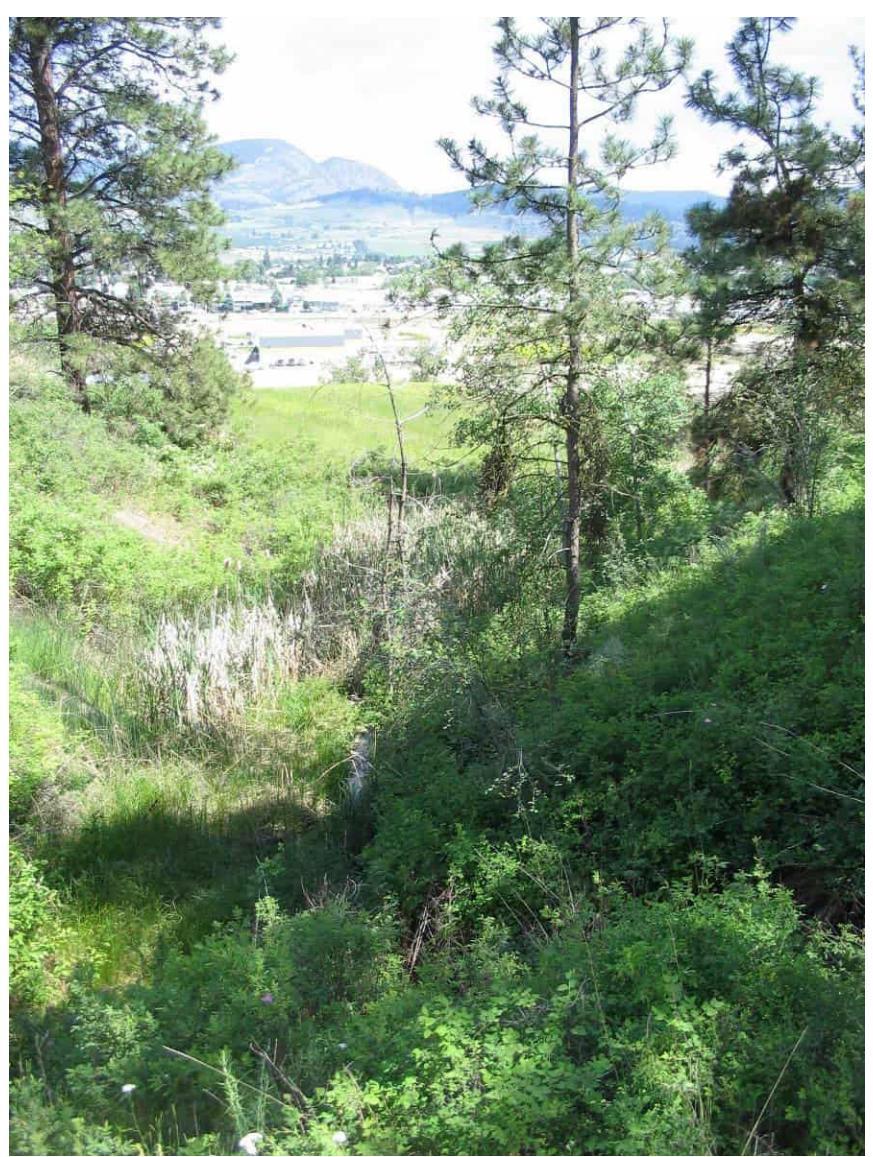
Photo 10. The above photo depicts the Douglas-fir – Water birch – Douglas maple (DM-PPxh1-08) community that lines the tributary to Mill Creek (Photo taken on June 11, 2008).

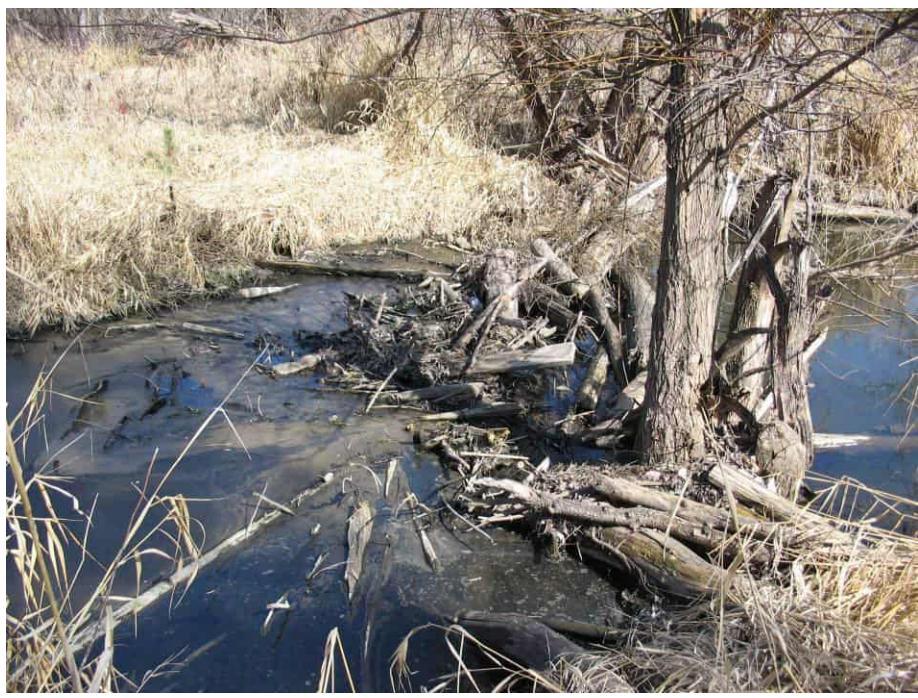
Photo 11. Depicts a beaver dam that was constructed along Mill Creek

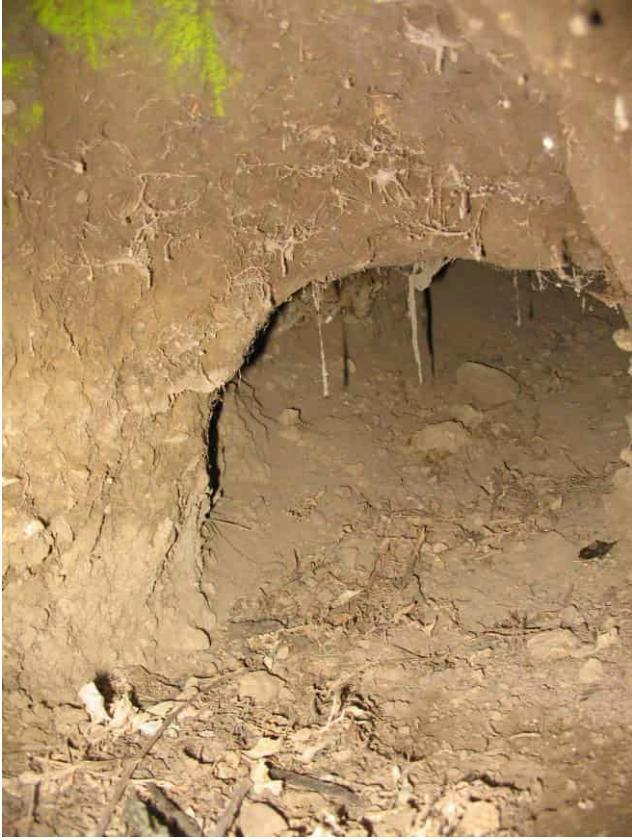
Photo 12. Depicts a single burrow that was apart of a network of burrows that occurred approximately 50 m from Mill Creek.

The study site is also utilized by deer, as scat, bedding sites and game trails were found throughout. Other species documented on site include Yellow Bellied Marmot (*Marmota flaviventris*) and Garter Snake (*Thamnophis sirtalis*). Additional evidence of species presence includes beaver dams, and a network of denning holes at the base of the hillside approximately 50 m from Mill Creek (**Photos 11 & 12**) (**Figure 2**). Ecoscape suspects that these dens are likely used by coyotes but may also support badger. Previous environmental reporting for the site indicated some evidence of badger activity near the south end of the subject property, however, nothing was observed to indicate a resident badger (Phillips 2006; Personal Communication -C. Hoodicoff 2008). During the September 12, 2019 site visit, Ecoscape identified two burrows near the north end of the site (**Figure 2**).

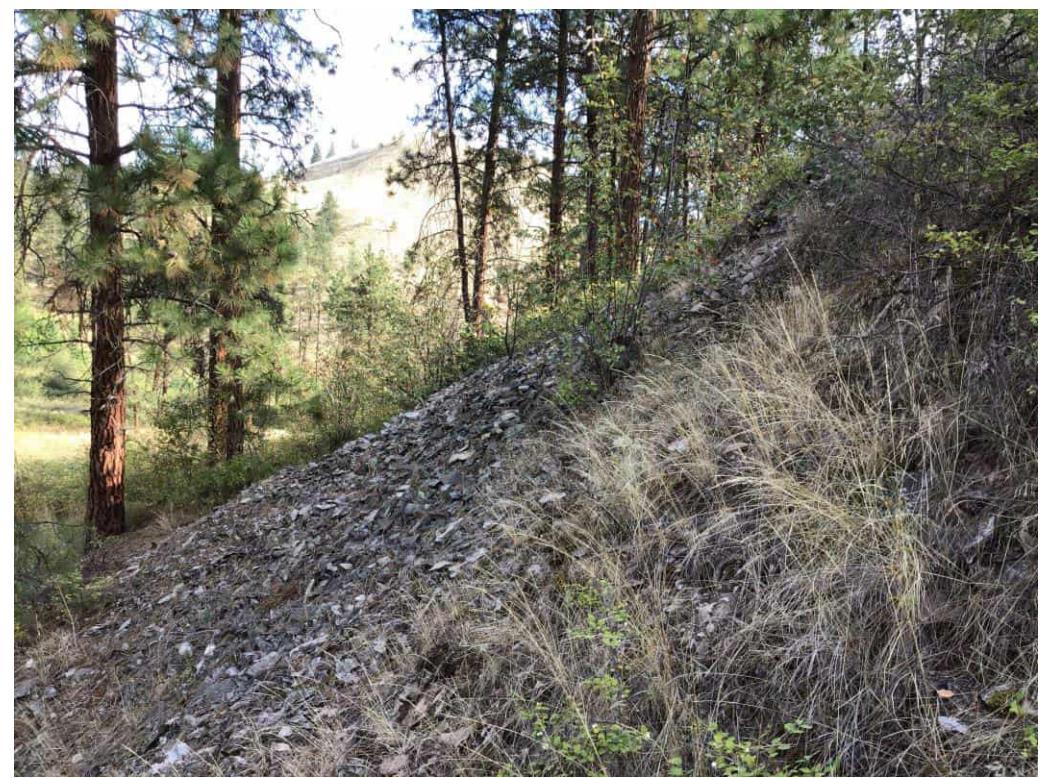
Photo 13. View of talus located within the northwest corner of the subject property (Photo taken September 12, 2019).

The relatively few pockets of coarse and fine talus found in the southwestern and northwestern portion of the subject property provide important habitat for reptiles (**Photo 13**). Reptiles in particular use these features for denning, security cover and basking sites. Reptiles that be most likely to utilize the subject property include the Racer (*Coluber constrictor*), Western Skink (*Eumeces skiltonianus*), Gopher Snake (*Pituophis catenifer deserticola*), common garter snake (*Thamnophis sirtalis*), terrestrial Garter Snake (*Thamnophis elegans vagrans*), and Northern Alligator Lizard (*Elgaria coerulea*). Ecoscape observed a Common Garter Snake in Mill Creek.

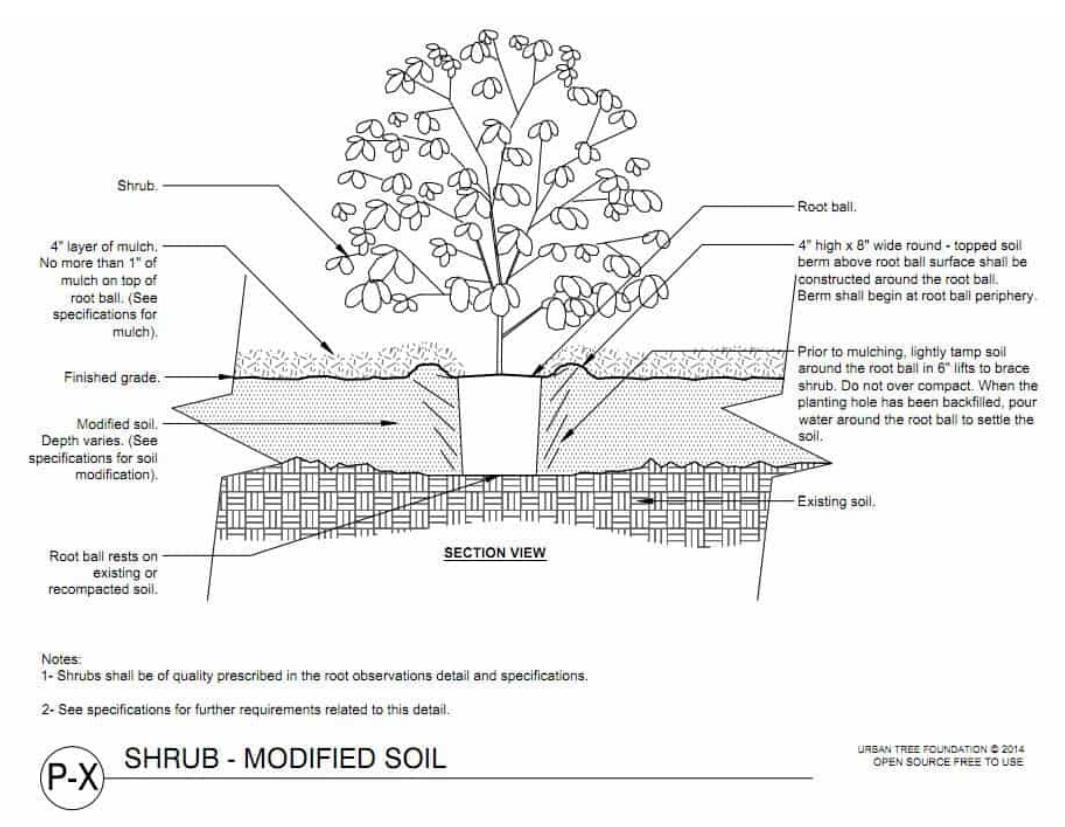
• Plants should be installed as shown in the typical drawing below. In general, the top of the root ball will be installed level with existing ground and the surrounding area covered with 5 to 10 cm of mulch. The excavation for the plant roots must be at least twice the width of the root ball and backfilled with excavated soil along with appropriate soil amendment (compost or mulch), if required. Hydroseed will be applied to all exposed soils and areas between plantings. The EM will review the plants, planting installation procedures, and condition following planting works.
